Sykeside Mill
Haslingden

A history and photographic survey

May 2002

A photographic survey and desktop study of Sykeside Mill was undertaken for Ivan Wilson, Architects, Clitheroe, prior to delisting and demolition of the mill. It had been seriously damaged by fire and had stood derelict for a number of years prior to the survey. Both survey and study were undertaken by Mike Clarke in March/April 2002.

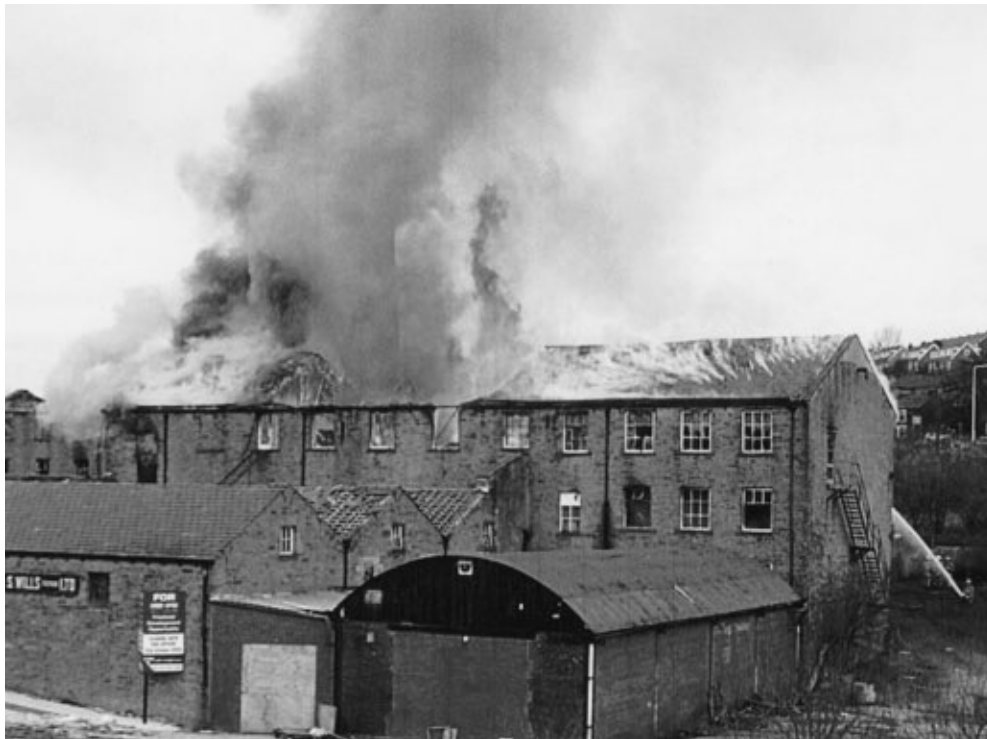
The mill on fire in 2000.

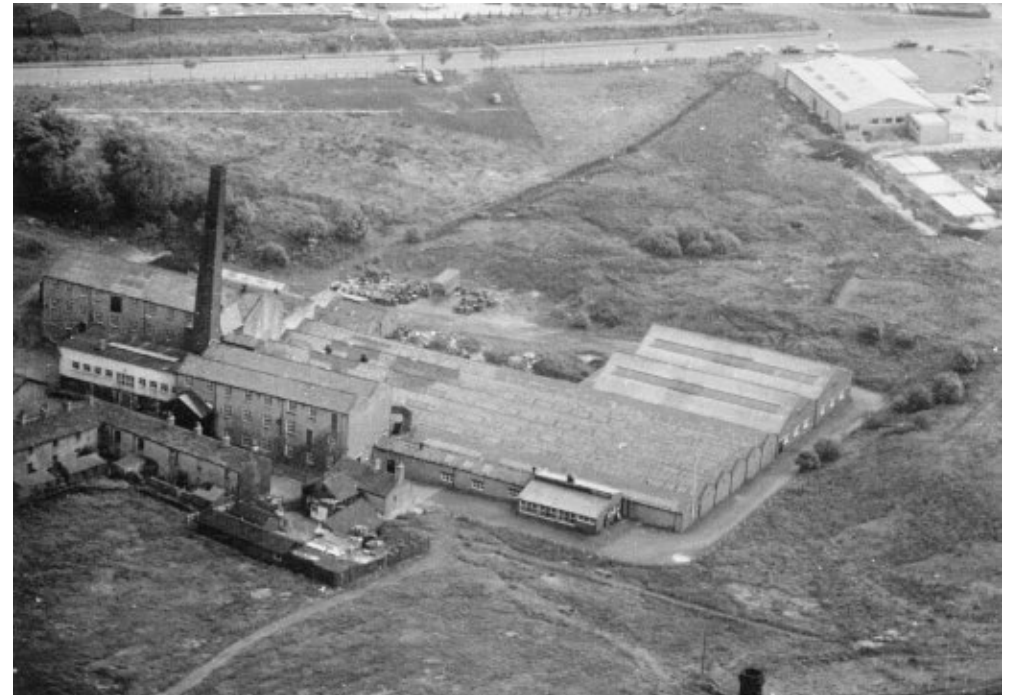
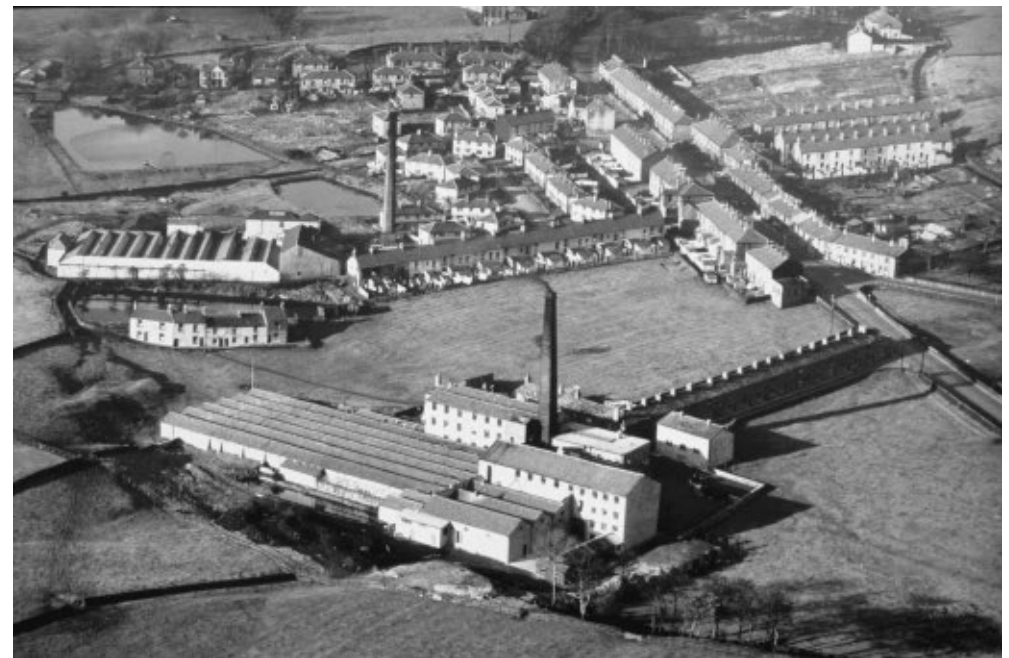
Aerial views of the mill in 1968 (above), and c1950 (below).

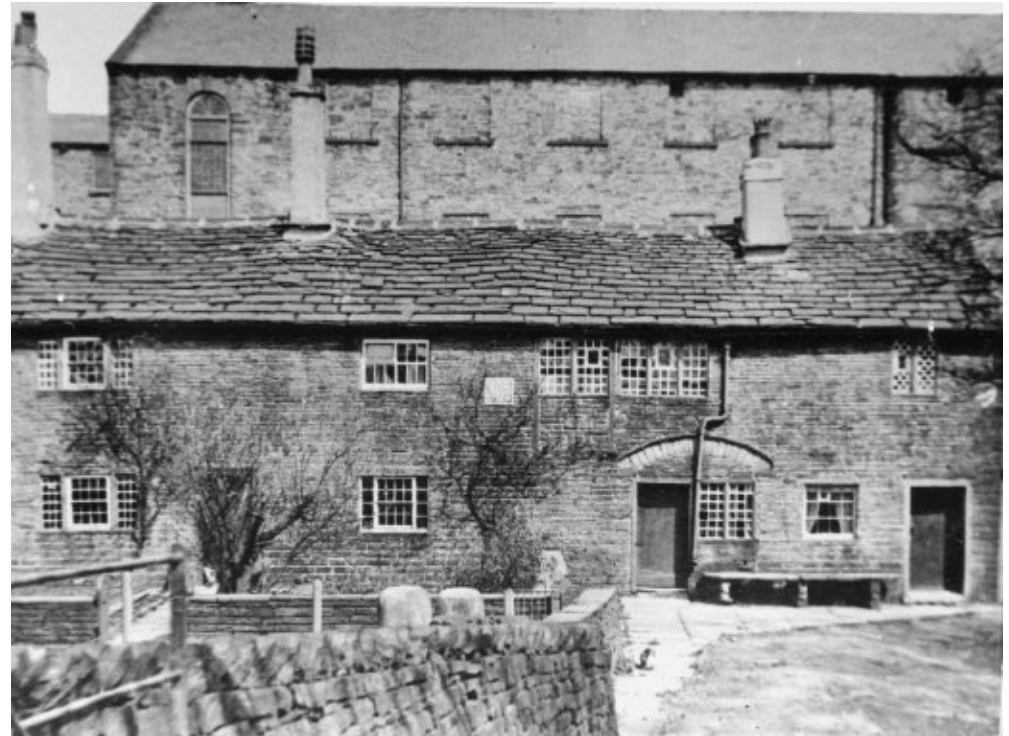
The mill yard and house in the 1920s.

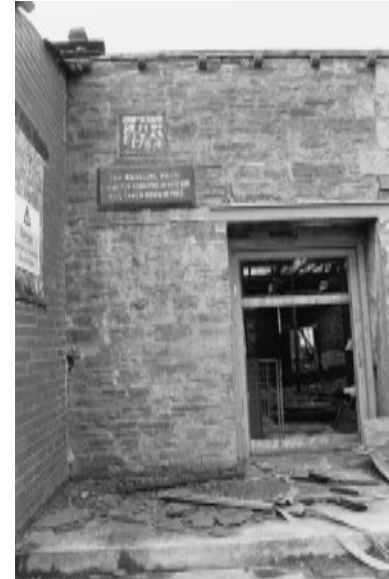
Negative no. 06A

Date stone from cottage which was replaced in 1907 by single storey stone built extension.

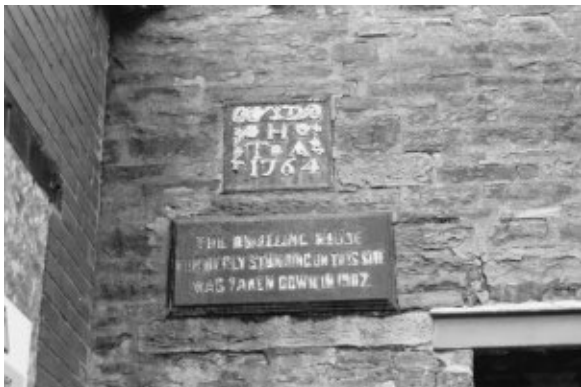
Negative no. 07A

Date stone from earlier house and commemorative stone erected in 1907 during mill extension.

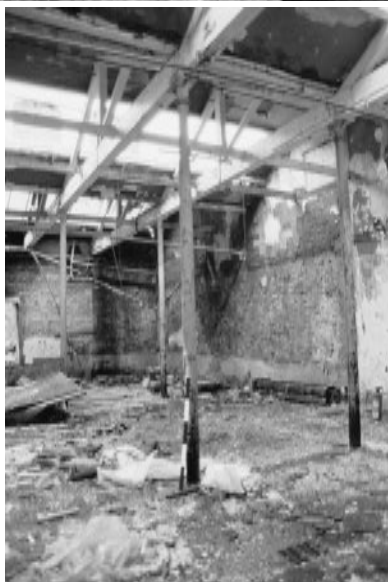
Negative no. 08A

Inside of 1907 extension looking northwards to wall of rear three storey building and showing an infilled window on the left.

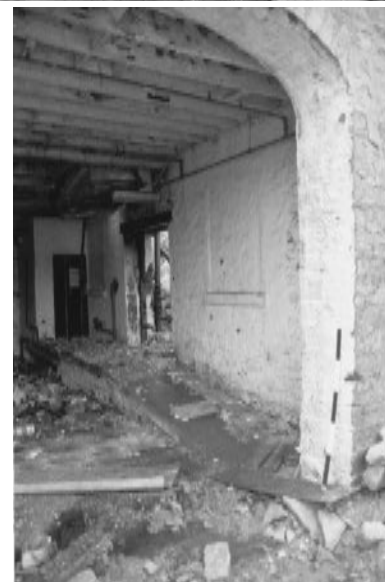
Negative no. 11A

View from the north side of the archway under the rear three storey building.

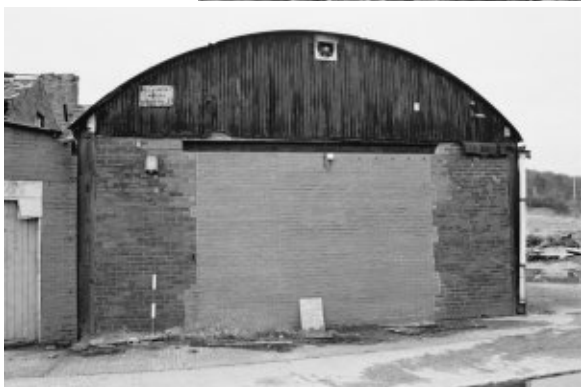
Negative no. 09A

South face of metal framed building at the south east corner of the collection of buildings.

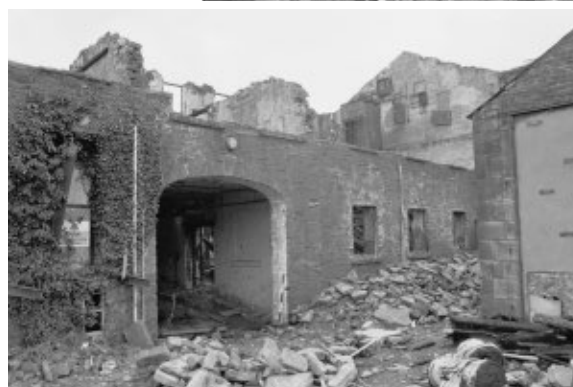
Negative no. 12A

View of the north side of the badly damaged rear three storey building with the boiler house on the right.

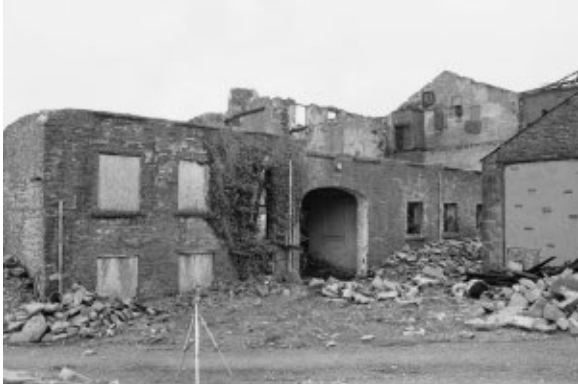
Negative no. 13A

View of the north side of the badly damaged rear three storey building with the boiler house on the right.

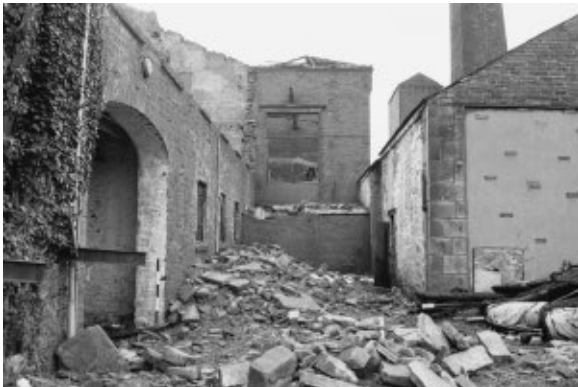
Negative no. 14A

View along north face of rear three storey building with brick extension for horizontal steam engine and boiler house on the right.

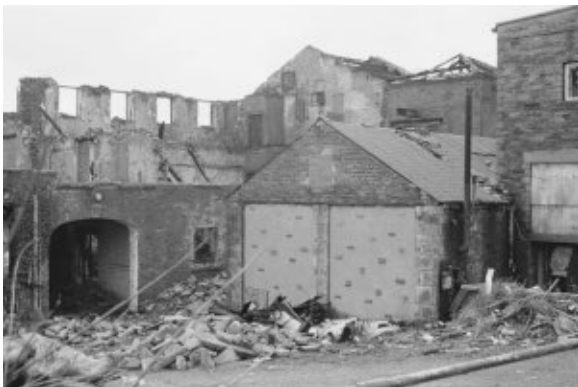
Negative no. 15A

View of the north side of the badly damaged rear three storey building with the boiler house and c1958 office block on the right.

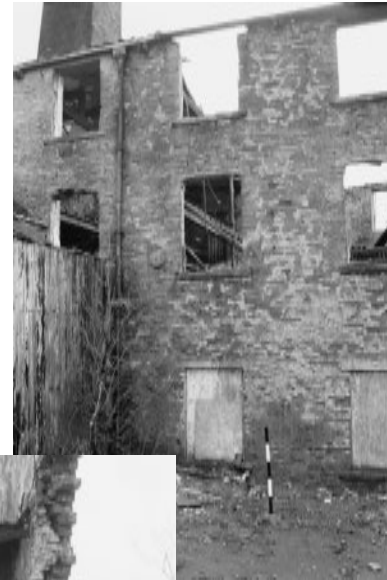
Negative no. 16A

North facing wall of the front three storey building with the down spout hopper dated 1839 on the left.

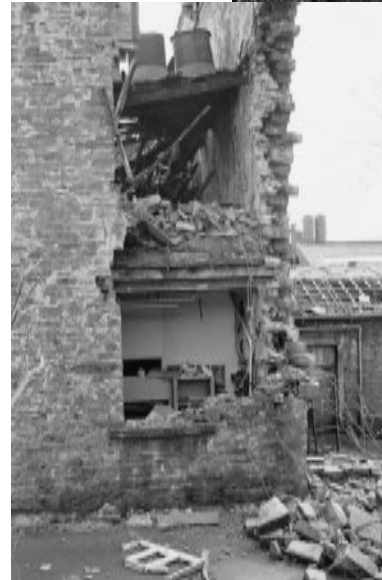
Negative no. 17A

North west corner of front three storey building showing fire damage and wall construction.

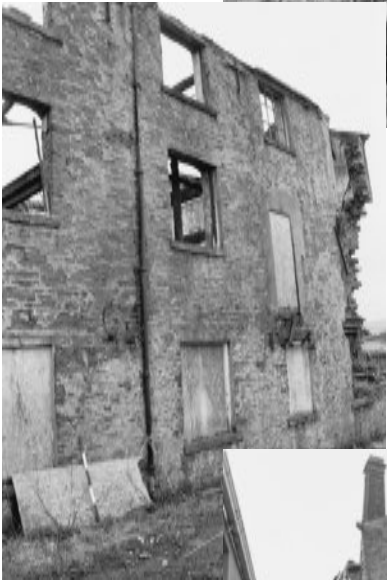
Negative no. 26A

The north face of the front three storey building with the join between the older part on the left and the newer section on the right immediately to the left of the down spout.

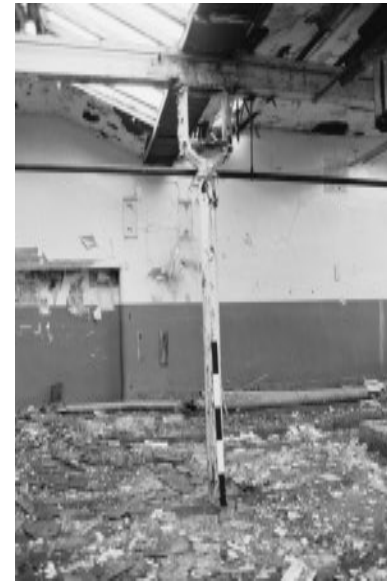
Negative no. 29A

The central columns in the weaving shed carried the bearings for the drive shafting. The western column had a different bearing housing shape. The end bearing box can be seen in the west wall of the shed. The guttering was cast iron.

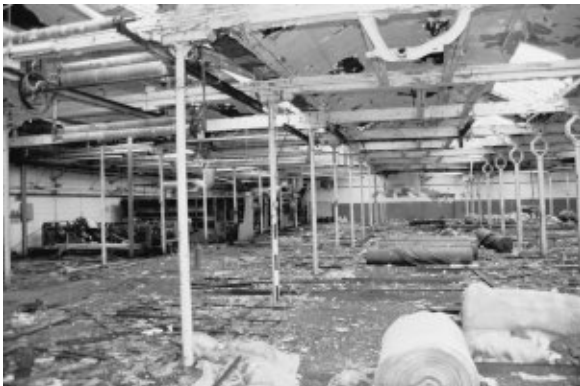
Negative no. 32A

View looking to the west in the weaving shed showing some of the counter shaft hangers and carriers.

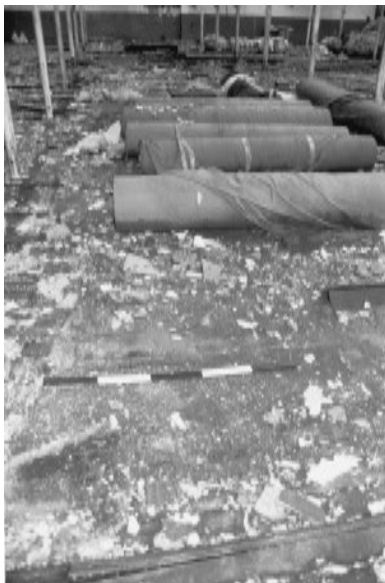
Negative no. 33A

View looking to the west in the weaving shed showing cast iron machinery fixing slots in the floor.

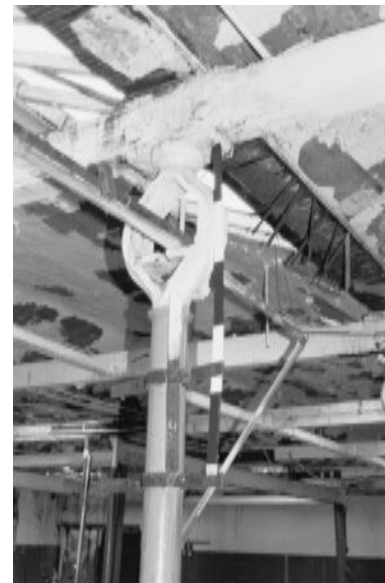
Negative no. 36A

Typical bearing housing in top of cast iron columns in the weaving shed.

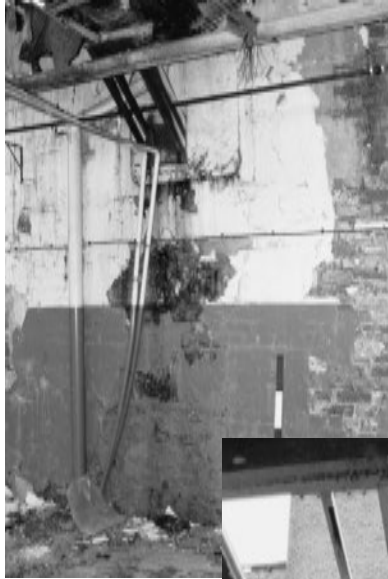
Negative no. 02B

Bearing box, on centre line of columns, in eastern end wall of the weaving shed.

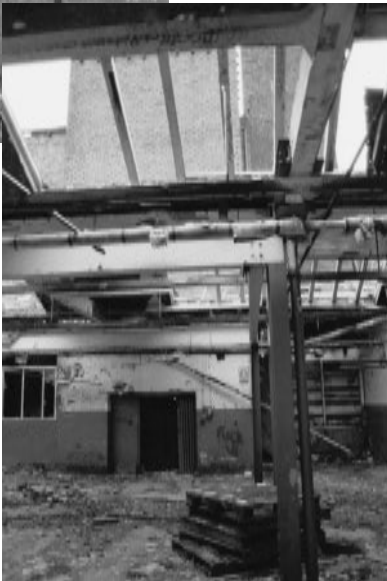
Negative no. 03B

View looking to the north at eastern end of the weaving shed showing the lift shaft built outside of the front three storey building and the location of the chimney.

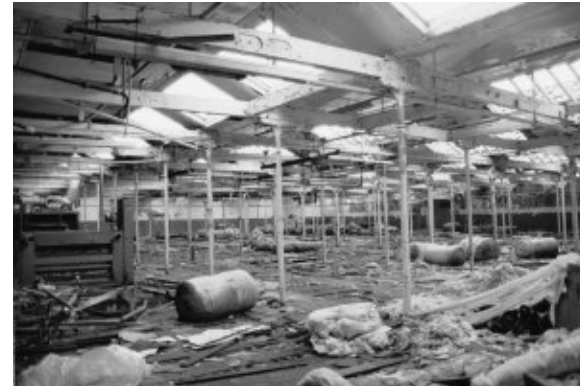
Negative no. 04B

View across the weaving shed from the south east corner showing old fixings for bearing supports rebated centrally into the roof support beams.

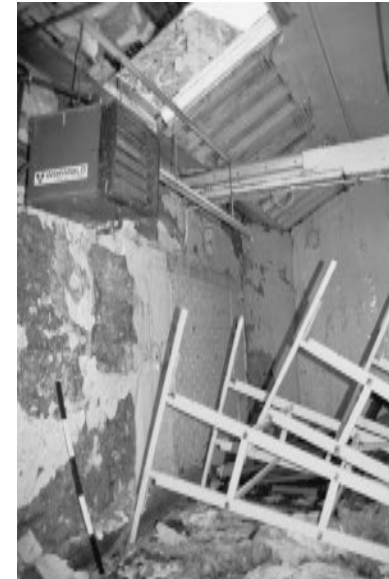
Negative no. 05B

North east corner of the single storey extension on the south side of the weaving shed showing the angled wall which was part of the 1907 mill extension and the brick filled former doorway.

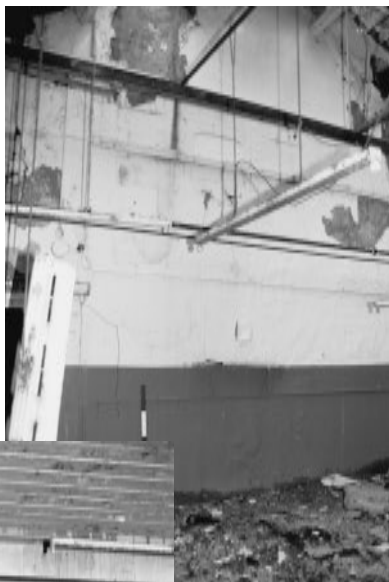
Negative no. 08B

Bearing housing in the east wall of the weaving shed seen from the 1907 extension for which it provided the drive. The drive was probably connected by a rope drive to the engine.

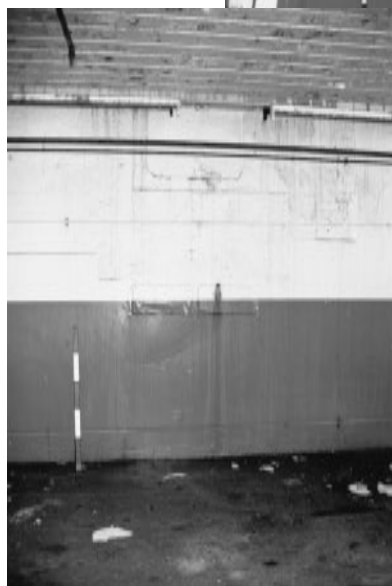
Negative no. 09B

Main bearing housing in the east wall of the weaving shed seen from the ground floor of the rear three storey building. The bearing is almost central within the building and the shaft was probably gear driven from the main engine drive shaft.

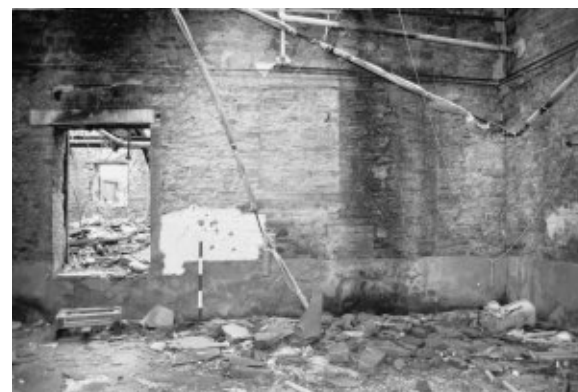
Negative no. 12B

Looking north at the south wall of the rear three storey building which formed the north wall of the 1907 extension. A walled-up window can be seen.

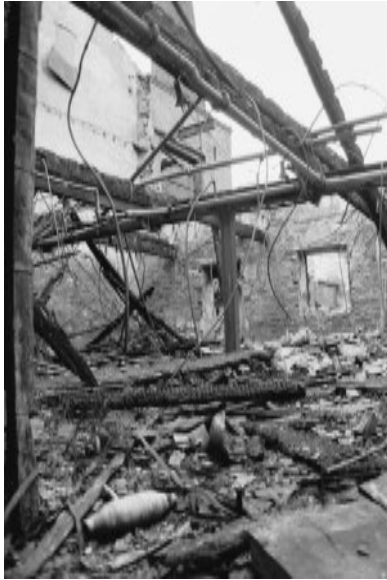
Negative no. 13B

Looking north west inside the remains of the rear three storey building at the intermediate wall, behind which was the engine, from the 1907 extension.

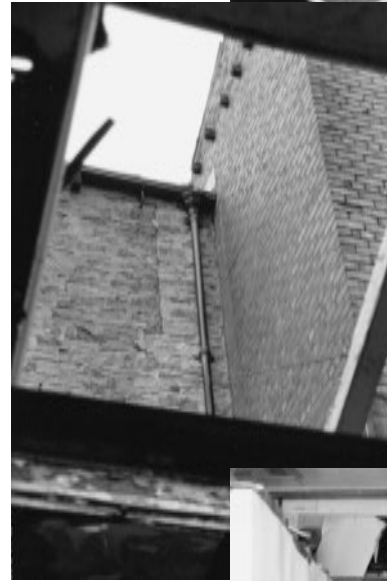
Negative no. 17B

Looking at the west side of the lift shaft and a walled-up window on the south face of the front three storey building.

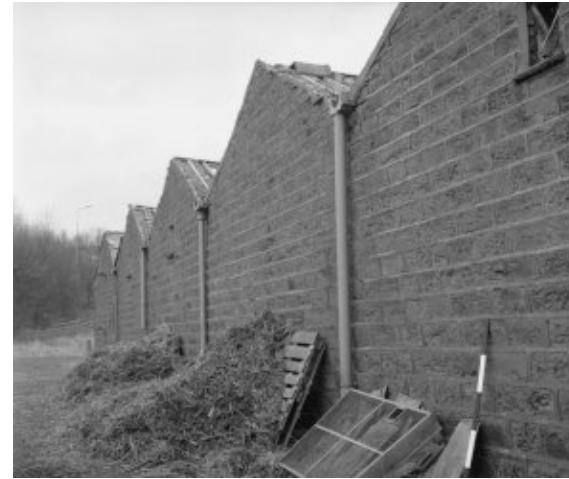
Negative no. 10C

The water-shot west wall of the weaving shed looking north.

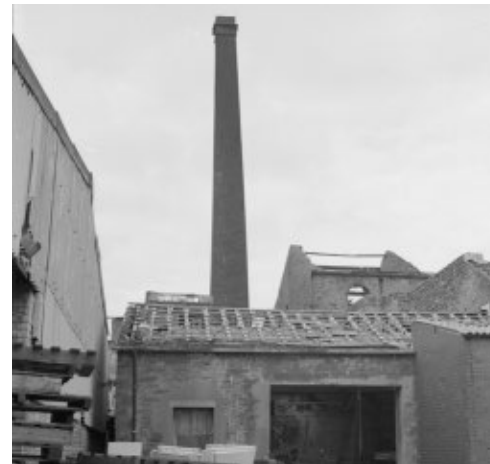
Negative no. 11C

The southern single storey extension to the weaving shed possibly built in 1907. The rounded top of the engine house window can be seen centre right.

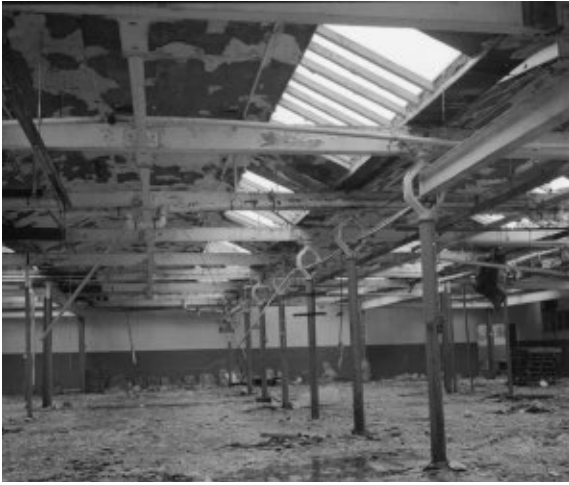
Negative no. 07D

Looking west from the east wall of the weaving shed showing the central line of columns with bearing housing for the drive shaft.

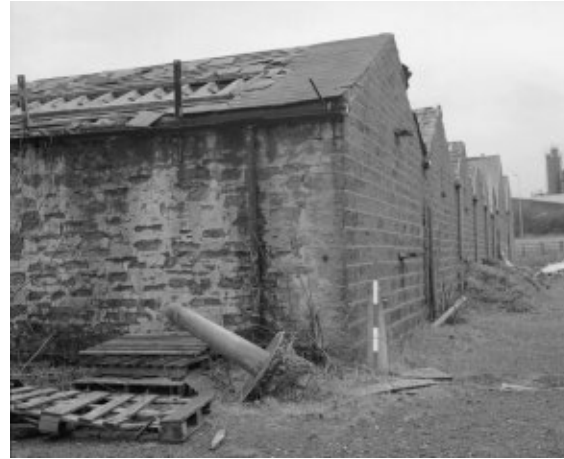
Negative no. 10D

North west corner of the weaving shed showing the water-shot stonework of the west wall.
