LOCKS

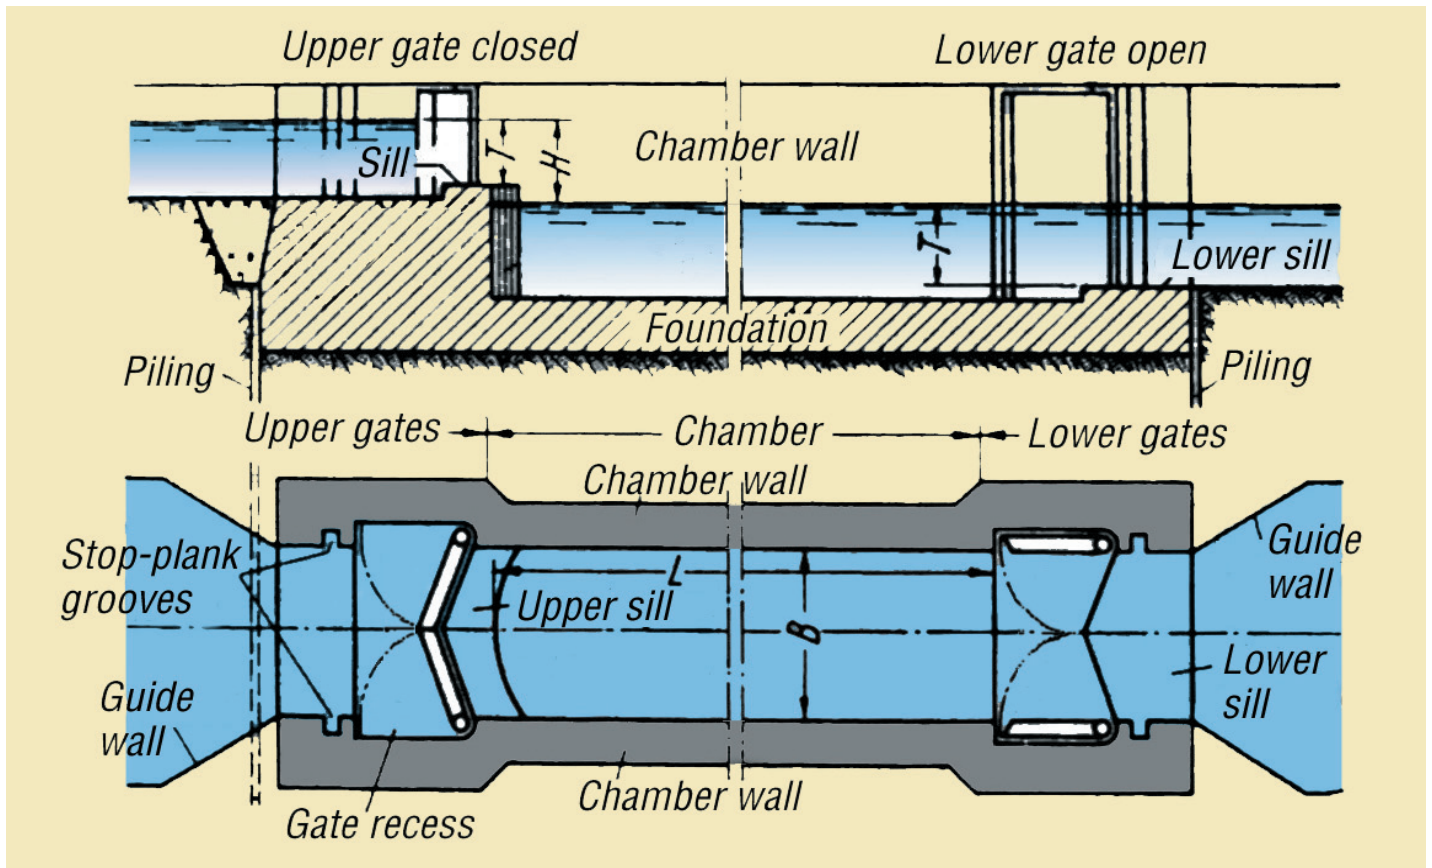
Above: The main structural features of a lock identified.

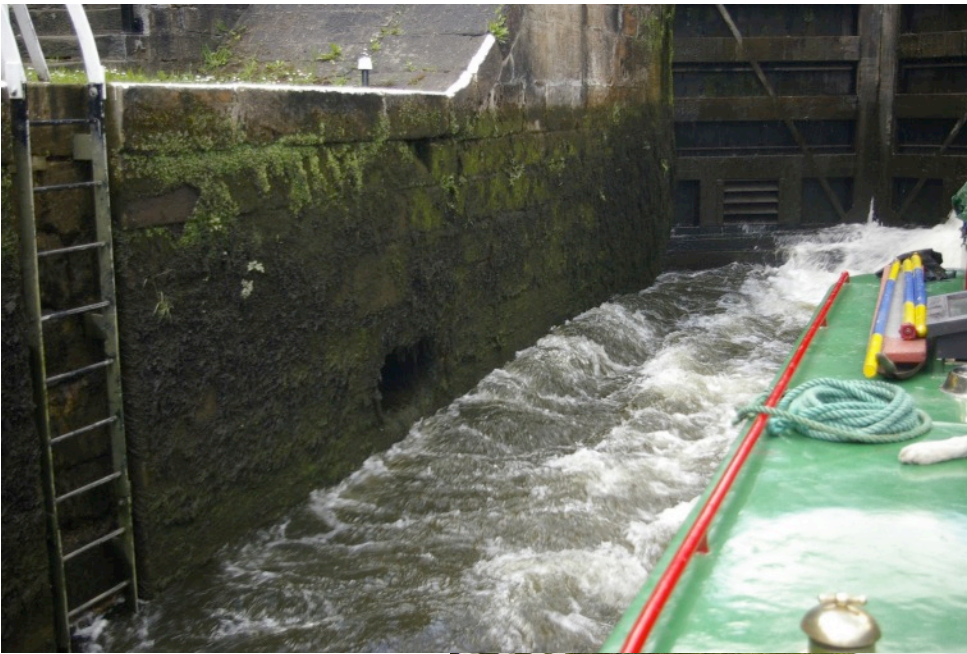
Going uphill, it is important to open the ground paddles first, and even then the water can be quite turbulent, as on the left.

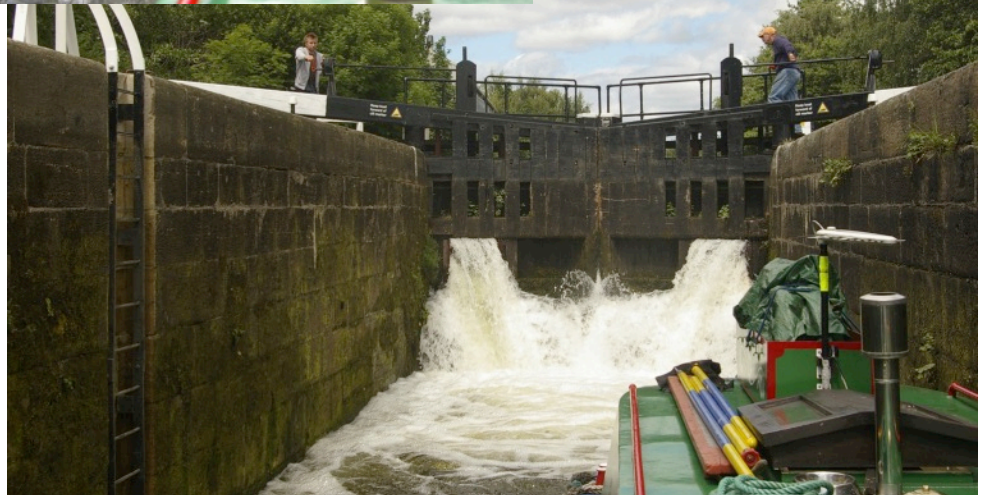
Below, the gate paddles have been opened before the water level has risen. With a boat which does not fill the lock, as here, it is not that dangerous, but should not be done with a full length boat.

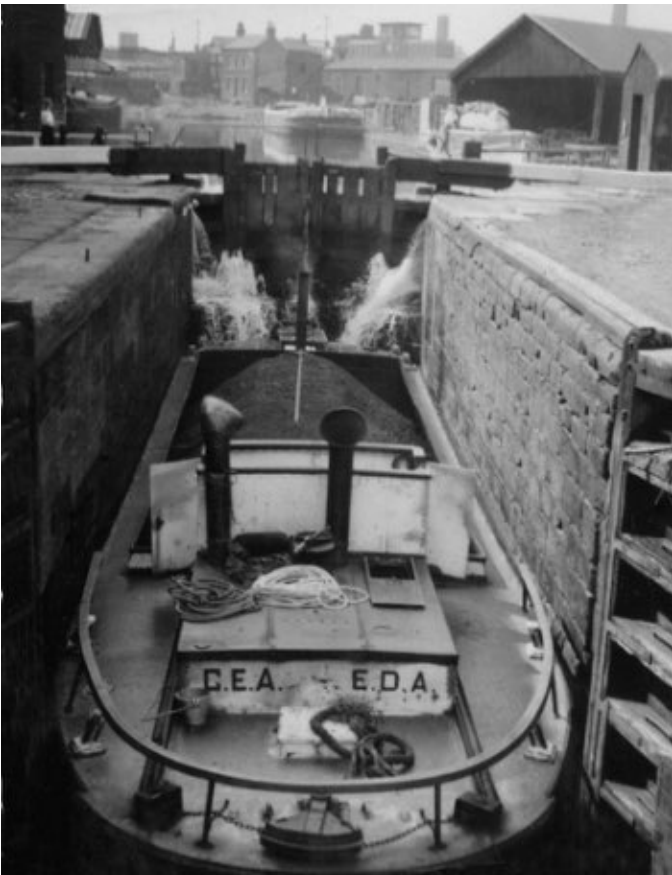
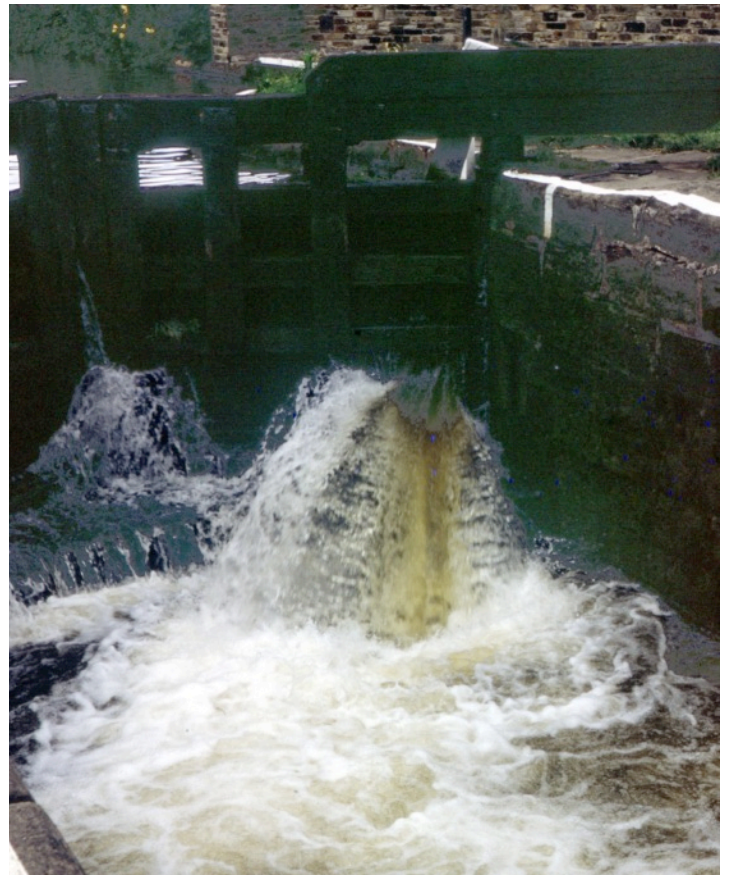
With a full length boat, as below left, if the gate paddles are opened too soon, the water can pour straight into the hold and sink the boat.

Today, baffles reduce the flow through gate paddles, but they used to be unrestricted, as below right, when it was much more important to be careful with opening the paddles.

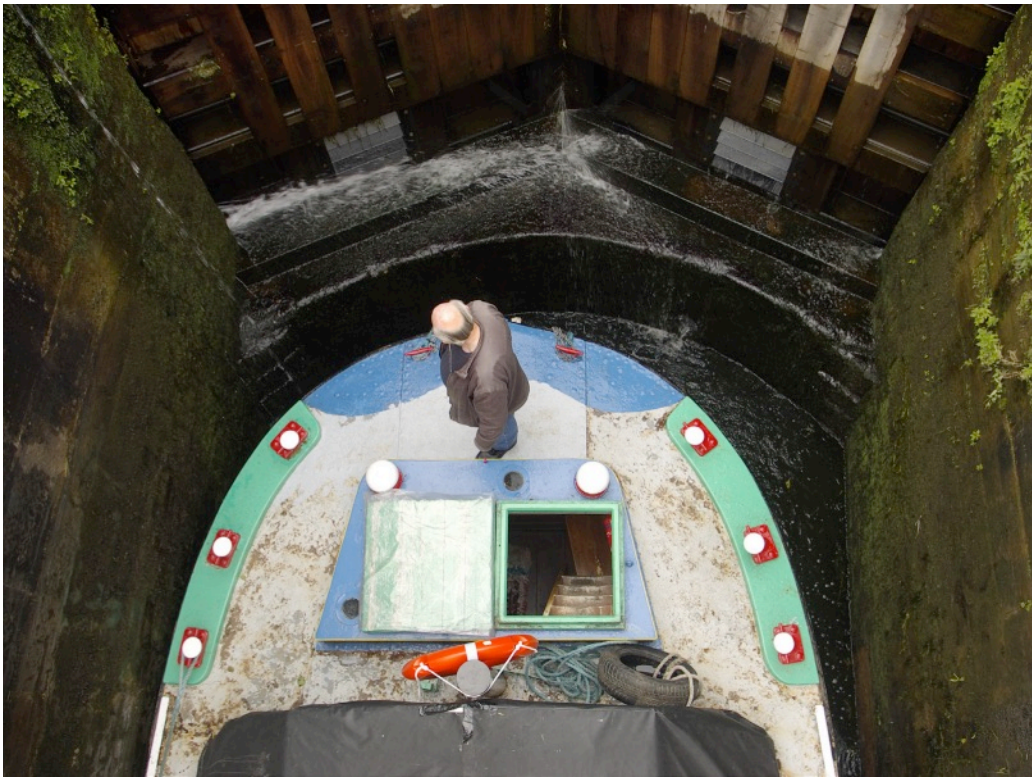
This is *Kennet* in Bingley 5-rise locks showing how close a full length boat gets to the gate paddle openings. Here they have been fitted with baffles. When the gates get older and start to leak, the hatch into the cabin has to be closed when working through locks.

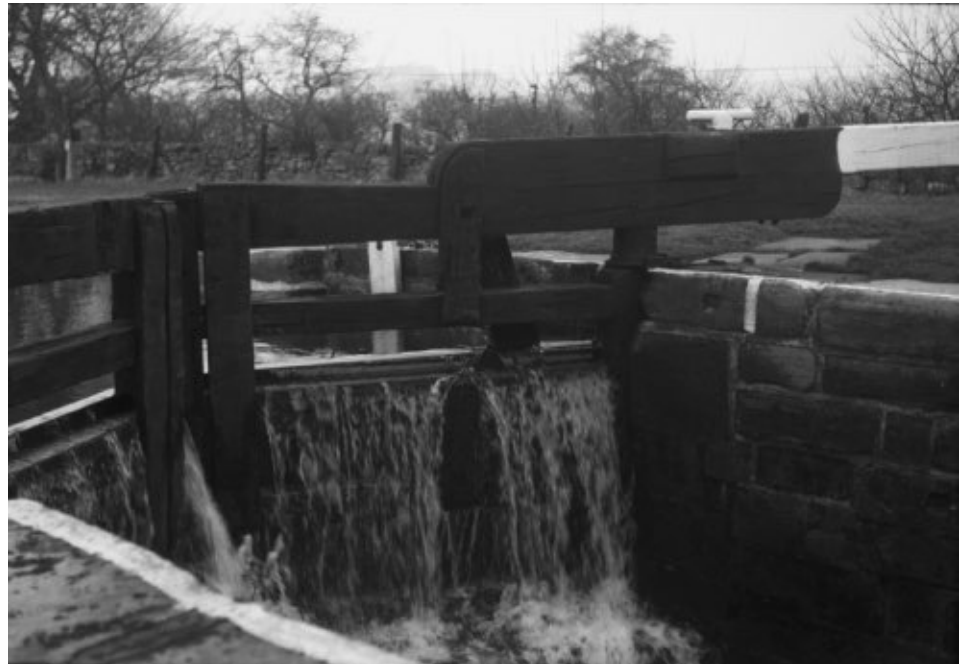
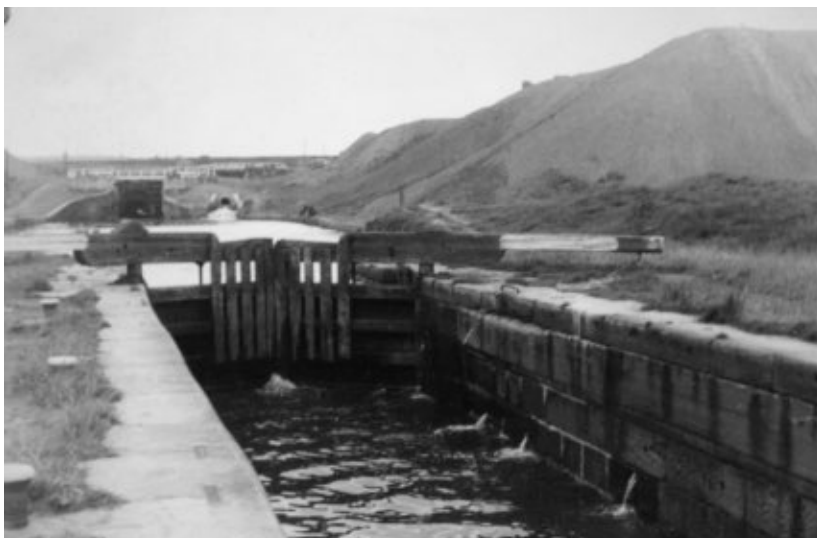
Having too much water, such as after heavy rainfall, can also be a problem in locks. The water level only needs to rise an inch or so for the water to flow over the top of the gates, and this too can cause problems for a full length boat working through the lock in either direction. Going downhill, it can become very wet for the steerer.

Lock chambers can also leak if water gets trapped behind the walls. This lock is at Wigan, where subsidence due to coal mining has caused many problems with lock structures. Today, concrete can be pumped into any spaces behind the wall to make the lock more structurally sound.

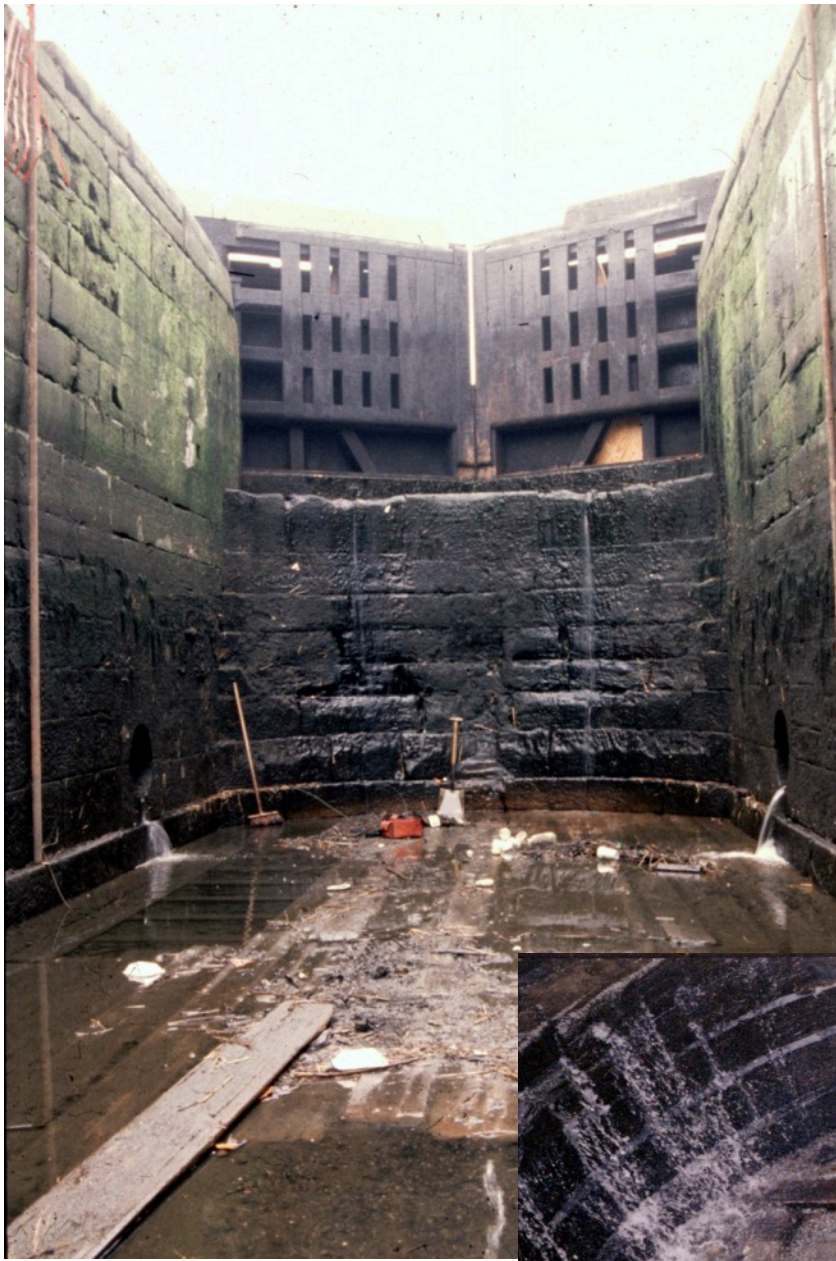
The locks built in the first phase of construction, in the 1770s, had wooden floors, with the stone lock sides built on top of a wooden foundation. Many of these lock floors have been replaced with concrete, though some are retained on listed locks.

The design of canal locks was improved over the years. These early locks had square entrances, as seen in the bottom photo of Forge Locks. The ground paddles were fitted to the front edge of the lock, where the square corners must have damaged boats as they entered the lock chamber. To overcome this problem, large pieces of timber were fitted which helped to guide a boat into the lock without striking a sharp corner. These can still be found on the locks between Leeds and Bingley, and at Appley Bridge in Lancashire, the earliest locks on the canal.

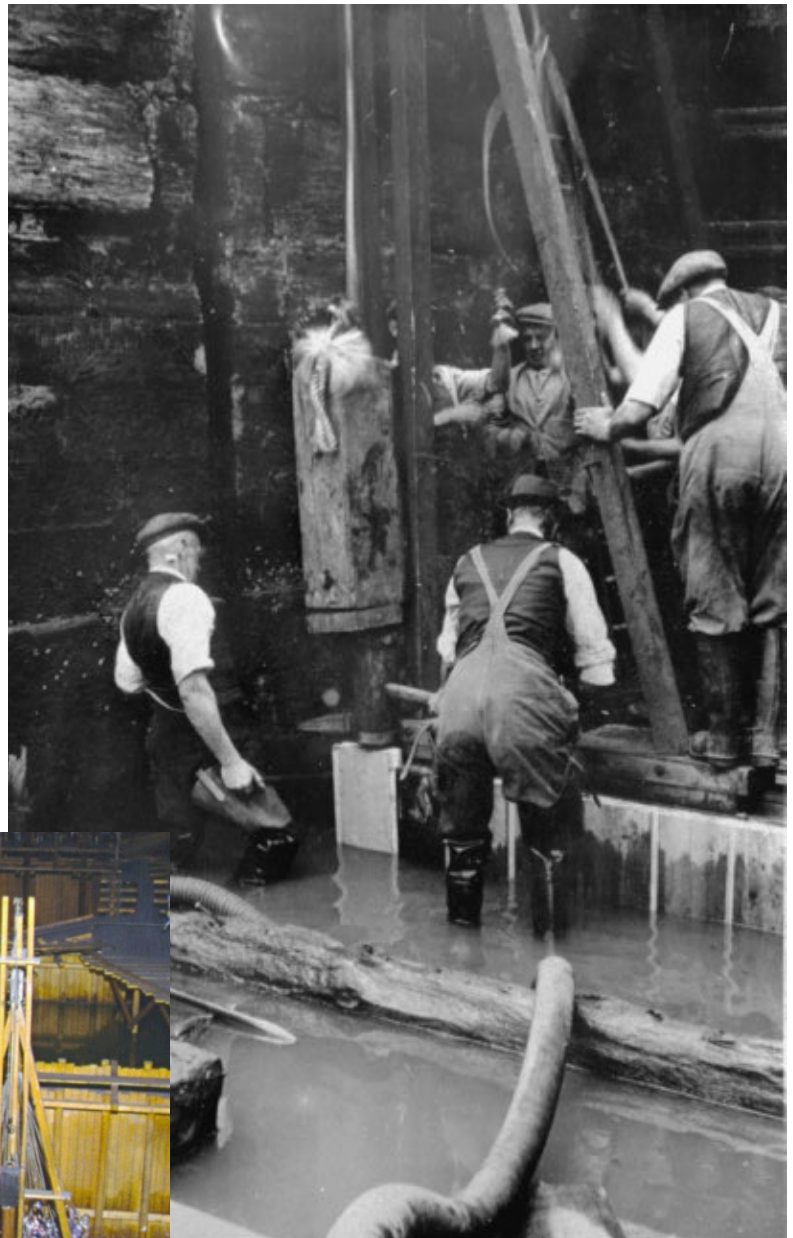
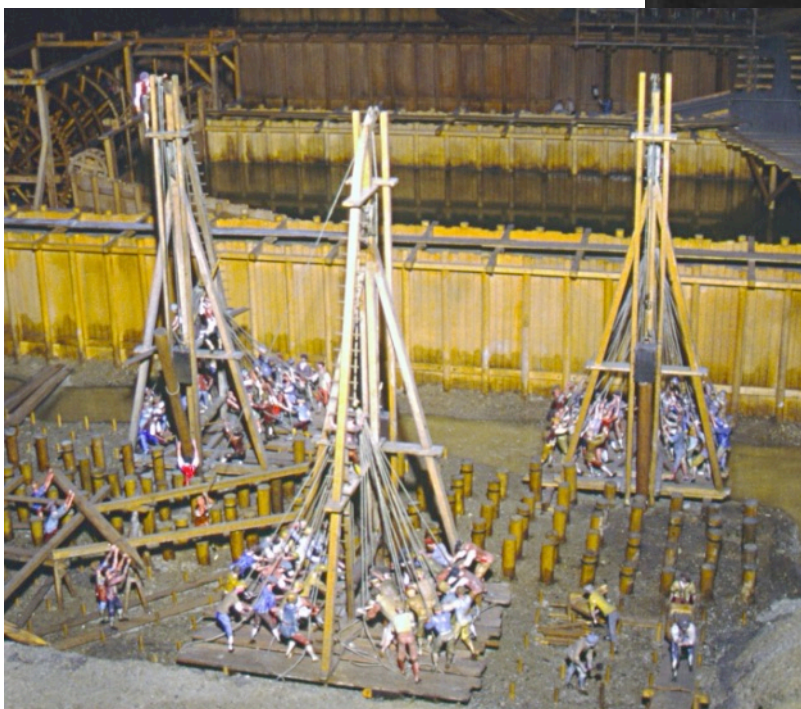
Manual pile driving continued to be used on the canal, as the 1953 photo on the right of Dobsons Locks at Apperley Bridge shows. They are putting a line of piles across the lowest end of the two-rise lock, probably to ensure that the sill, the wooden beams that the gates seal against, remains immovable.

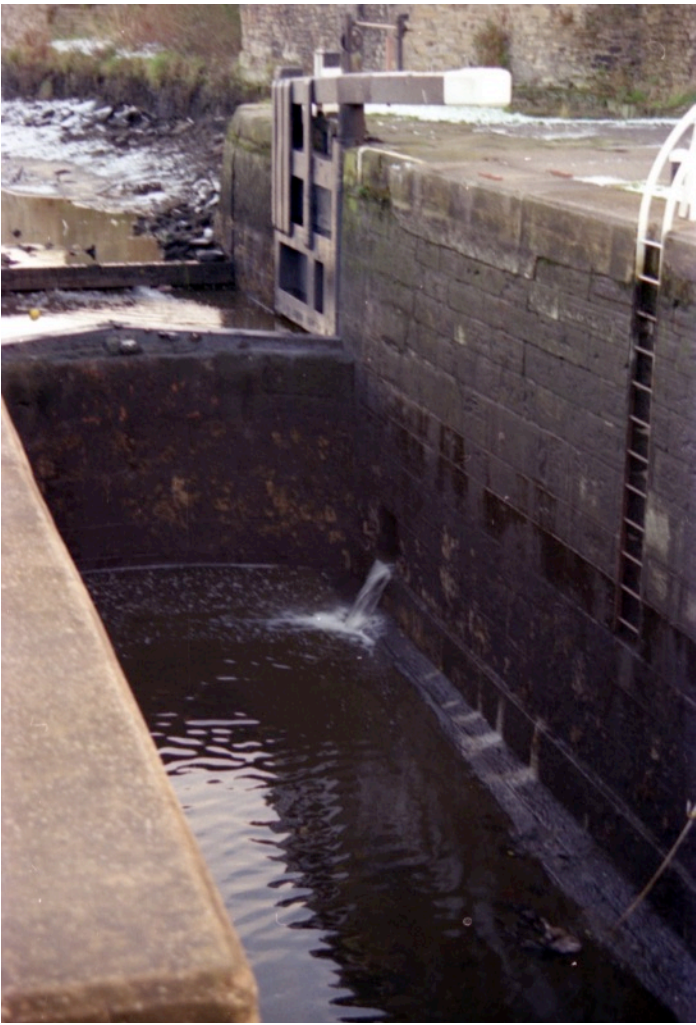
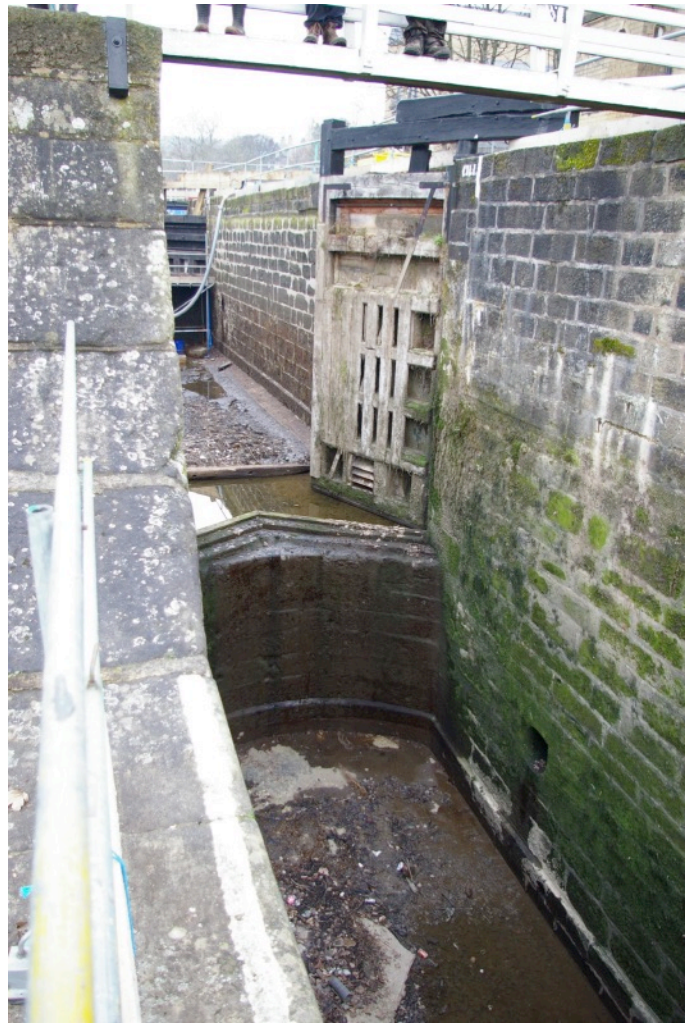
By the 1790s, canal engineering had advanced, and the locks were built with stone inverts, the slightly curved stone floor forming the foundation. The lock at Blackburn, shown above left and built around 1810, is typical. On riser locks, as at Bingley 3-rise on the right, the upper chamber had a stone floor, while the lower ones were wood. The sill floor could be built of stone, though sometimes it continued to be made from timber, as shown below on one of the Yorkshire locks. The baulk of timber fitted across the lock is there to help stop rubbish from settling on the sill and spoiling how the gates seal.

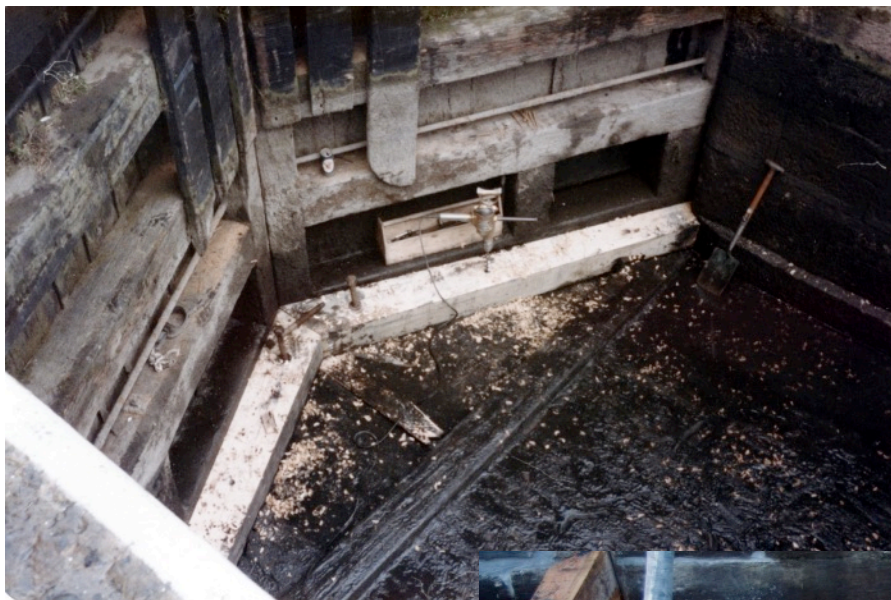
The photo on the left shows a wooden sill being fitted. The gates press against the wood to form a watertight seal, the sill, which is bolted down, also resting at either end against the chamber walls to help withstand the water pressure.

The gate swings on a pin fitted to it which sits in a bearing box. Here, the hole for the bearing box is being cleaned, with a new one sitting upside down on the stonework of the sill ready to be fitted. It has to be positioned accurately, such that the gate forms a seal in the quoin but can still be turned easily.

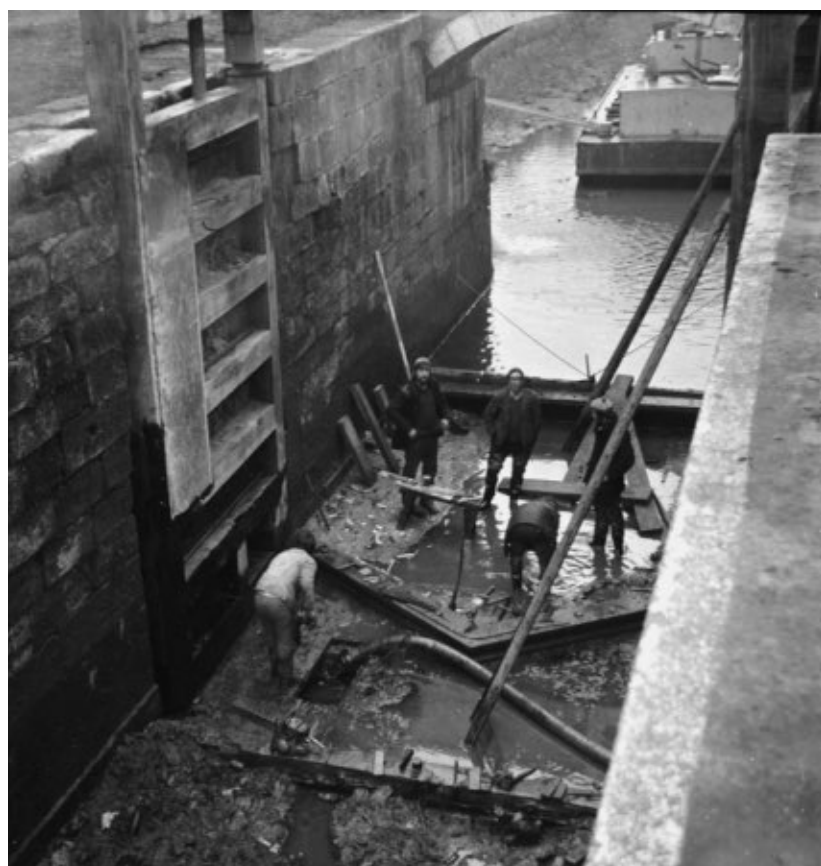
Working conditions can be very muddy, as this photo shows. Note the beam across the lock tail which is keeping the water out. This also serves to keep rubbish away from the sill when in use.

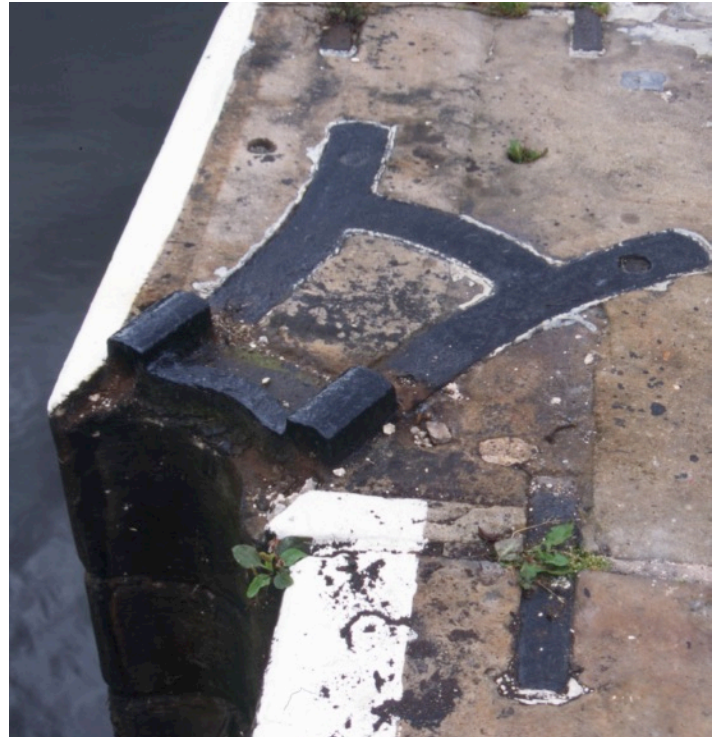
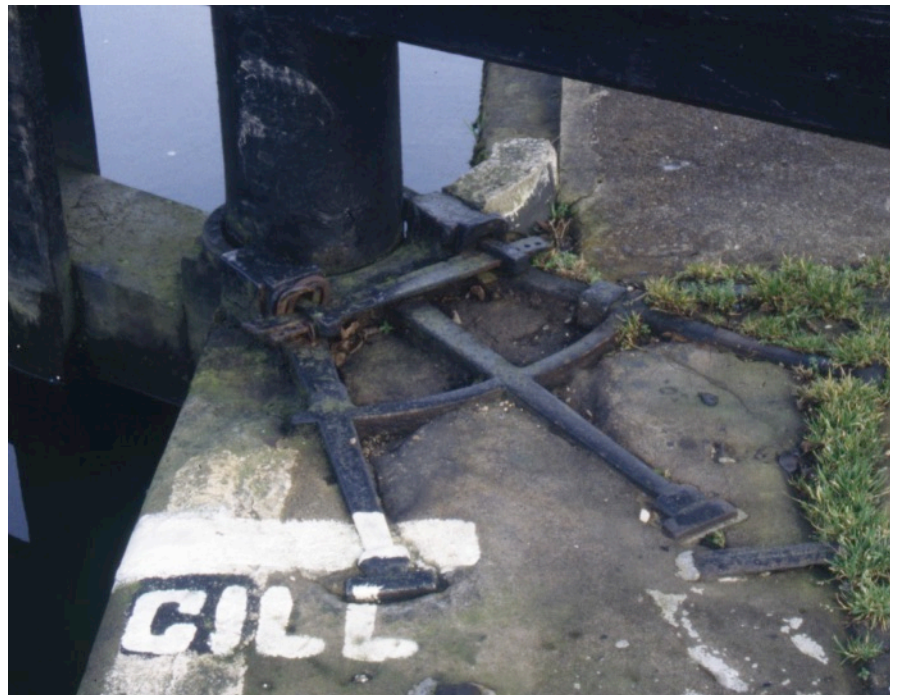
Gate anchors are used to hold the gate in place. The design of these has changed over the years, and two are shown here. The lower photo shows one of the early three-pronged designs, while the second photo shows a cast iron triangular pattern used in the second half of the 19th century. Other designs can be found, such as the modern welded pattern used more recently.

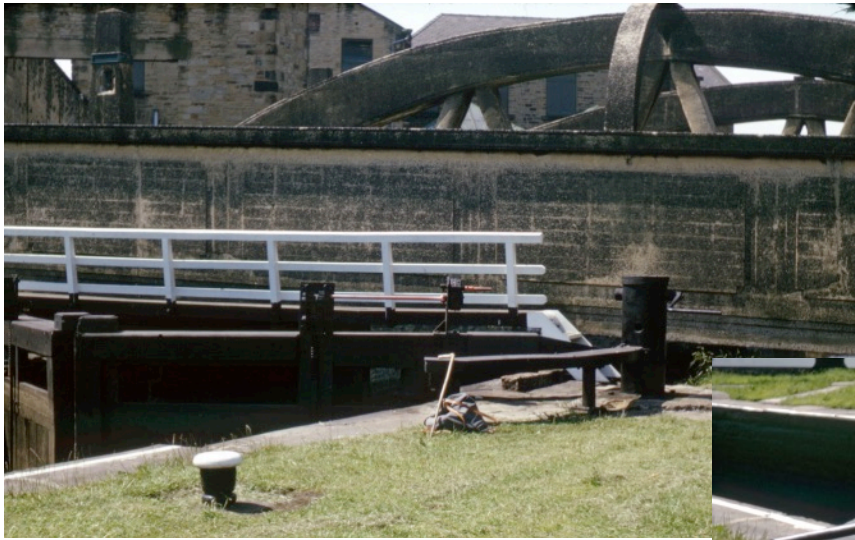
The gates, although basically similar, had variations in the balance beam depending upon where they were installed and which workshop built them. Old-style gates, they would last about thirty years, had 'piggy-backed' balance beams made of two pieces of timber, as above at Apperley Bridge.

At Bolton Road, Blackburn, the road bridge was widened and special cast iron quadrants had to be fitted to allow the gates to open.

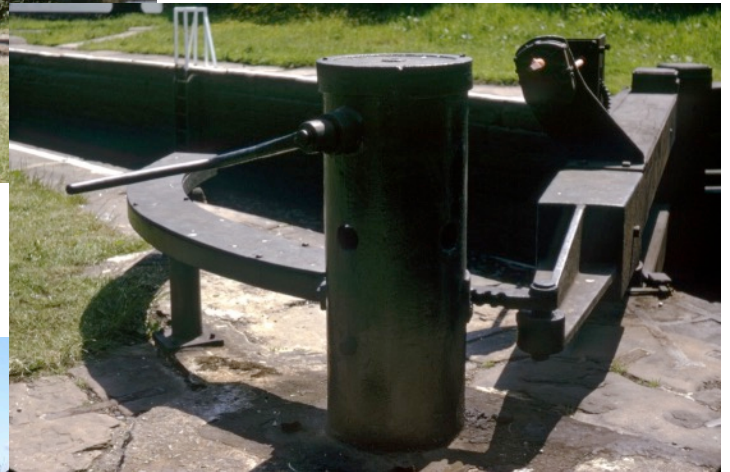
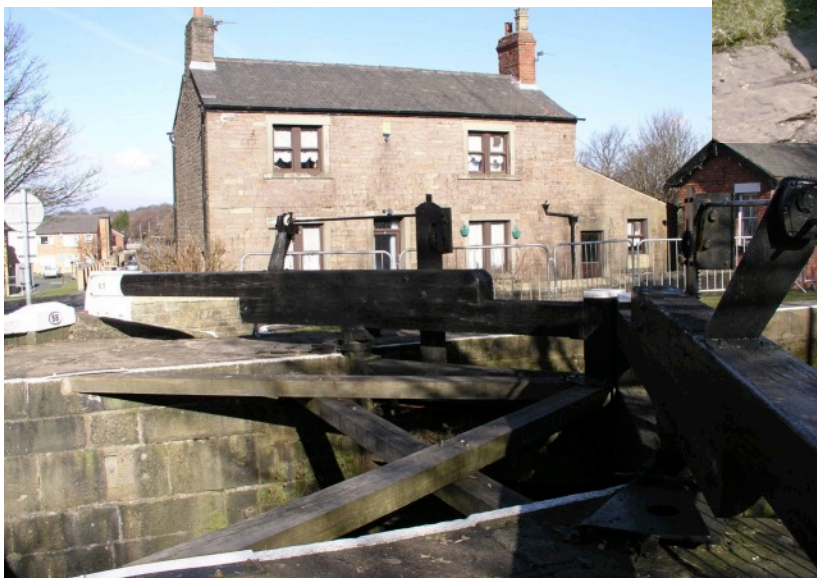
Wigan locks, the Top Lock is shown left, had a major problem with subsidence both varying the fall and distorting the chamber shape. Several locks had to have wooden strengthening frames fitted, as here, to ensure the mitre met correctly each time the lock was used.

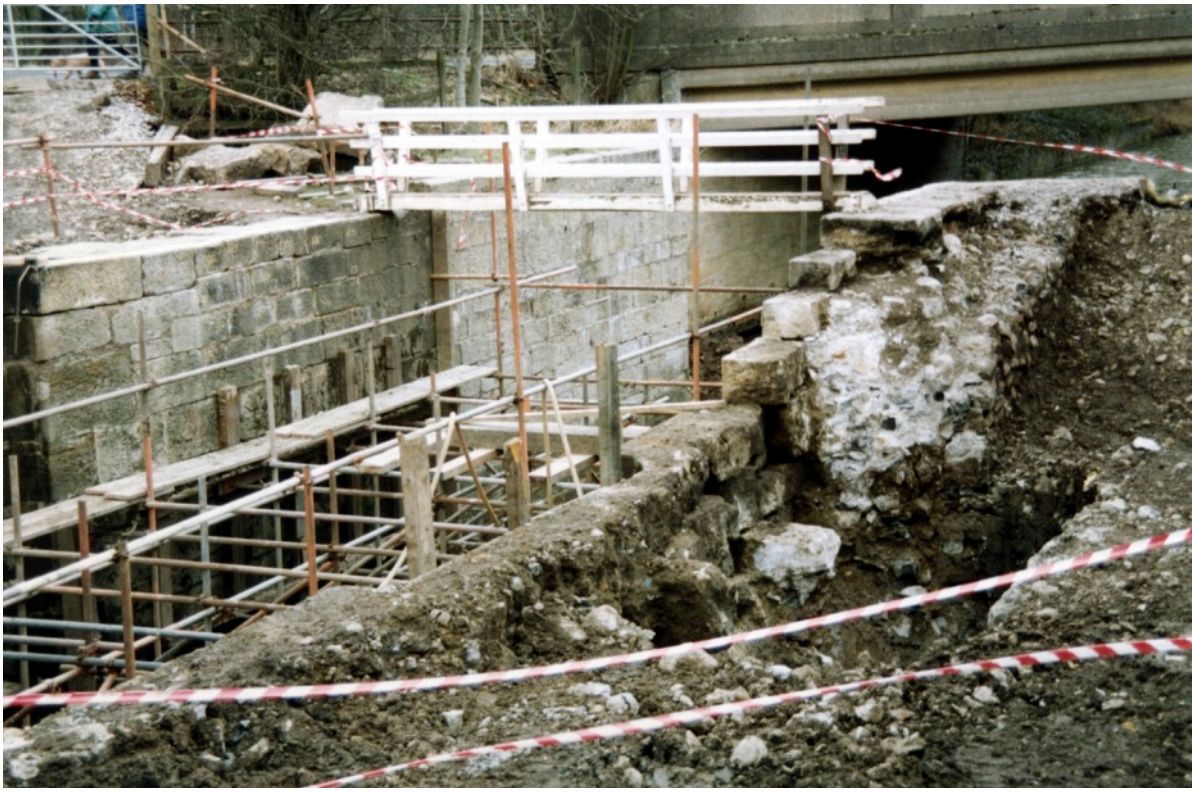
This is Anchor Lock chamber wall during a major repair. The wall is mainly a single stone thick, so there is always a danger of leakage through the wall causing a problem. This photo shows the lower gate recess, where the stonework just below has been built stronger, as this is where the pressure from the gates acts. The force in line with the stonework is greater than that trying to push the walls outwards.

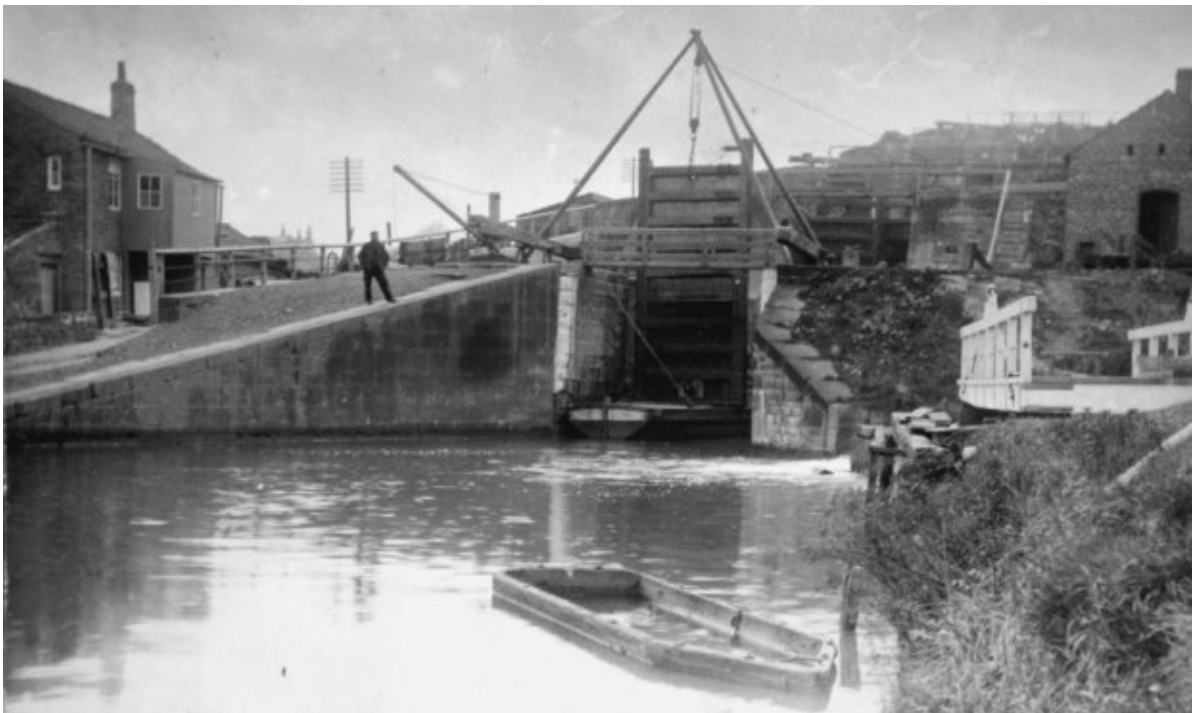
Bingley 5-rise, with a gate being replaced using sheer legs. There was a carpenters' yard at Bingley, seen here on the left, and new wooden swing bridges were certainly built on the ground on the right-hand side. The new gate may have been built here, or it could have been brought from Apperley Bridge on board the carpenters' boat seen below the locks. These boats were smaller than normal canal boats, being around 10 feet wide and forty feet long. They could easily carry a lock gate and were stable enough to provide a platform for working from when the lock was still in water. There were smaller 'flats', as seen in the foreground, but these were only used by men working on the locks or elsewhere, and they were not large enough for carrying objects.

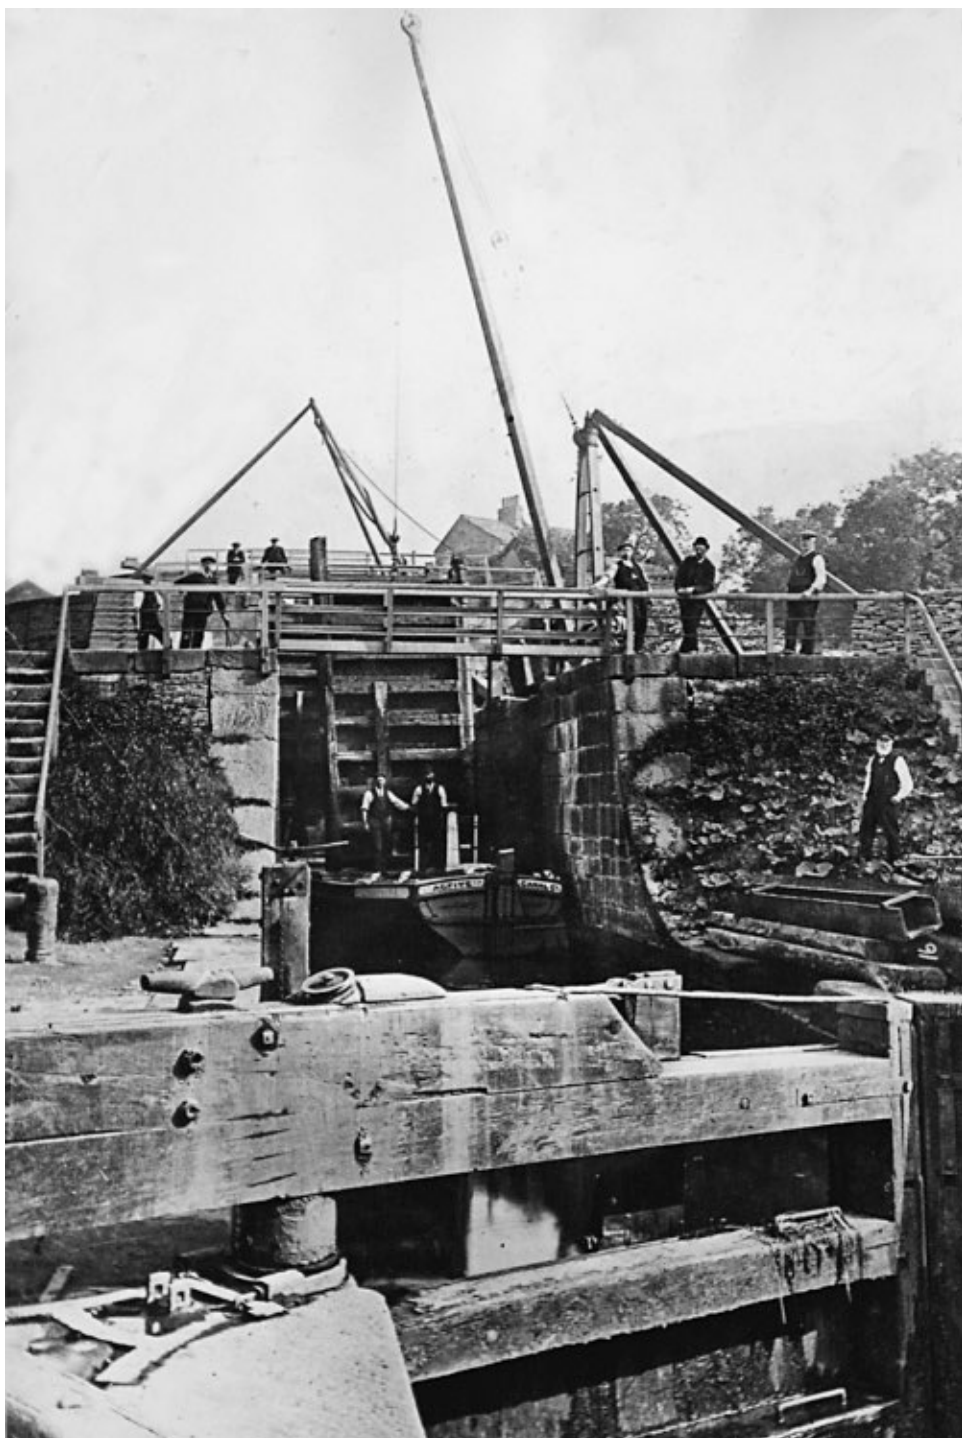
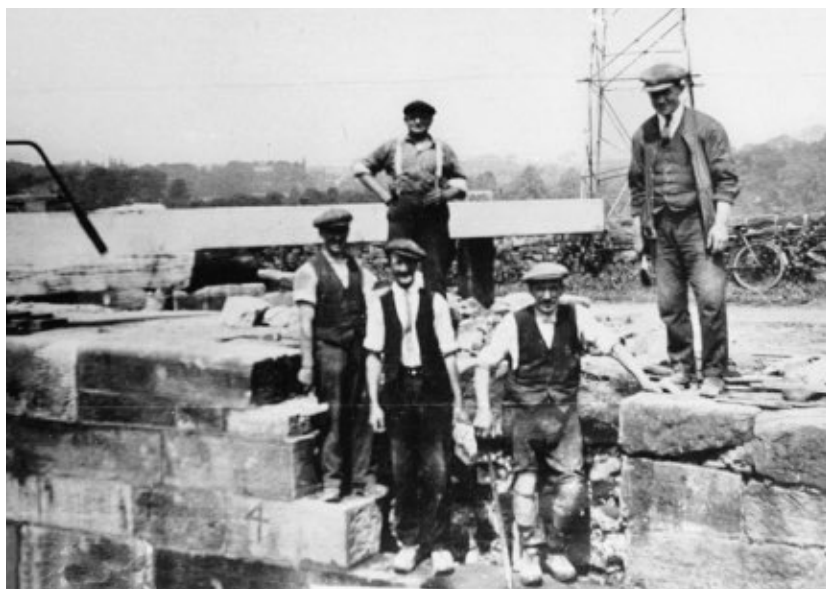
Bingley 5-rise locks during gate repairs. A large derrick crane has been erected for lifting one of the bottom gates — they were taller than on conventional single locks, where sheer legs were used for lifting, as can be seen in the background, ready for use on the smaller top gates. The photo also shows the carpenters boat *Active*, which could be making ready to load one of the larger gates. Note the lock gate furniture — the staples which allowed boatmen to climb up and down the gates, the pulley for the towline, and the cleat for holding a boat forward, away from the sill.

Lock wall repair was quite common, and in a few cases a date stone was added. This is a more typical repair, possibly to Kirkstall Lock. Note how some of the stones have been numbered to make refitting easier.

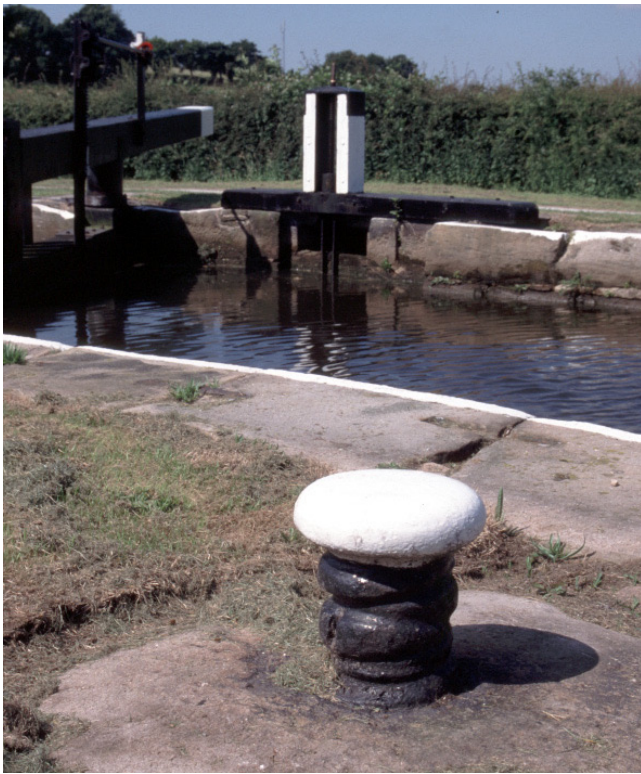
Horse-drawn boats entering a lock were stopped by a rope around a bollard. As it stopped, the boat would hit the side of the lock, and the damage caused can still be seen today.

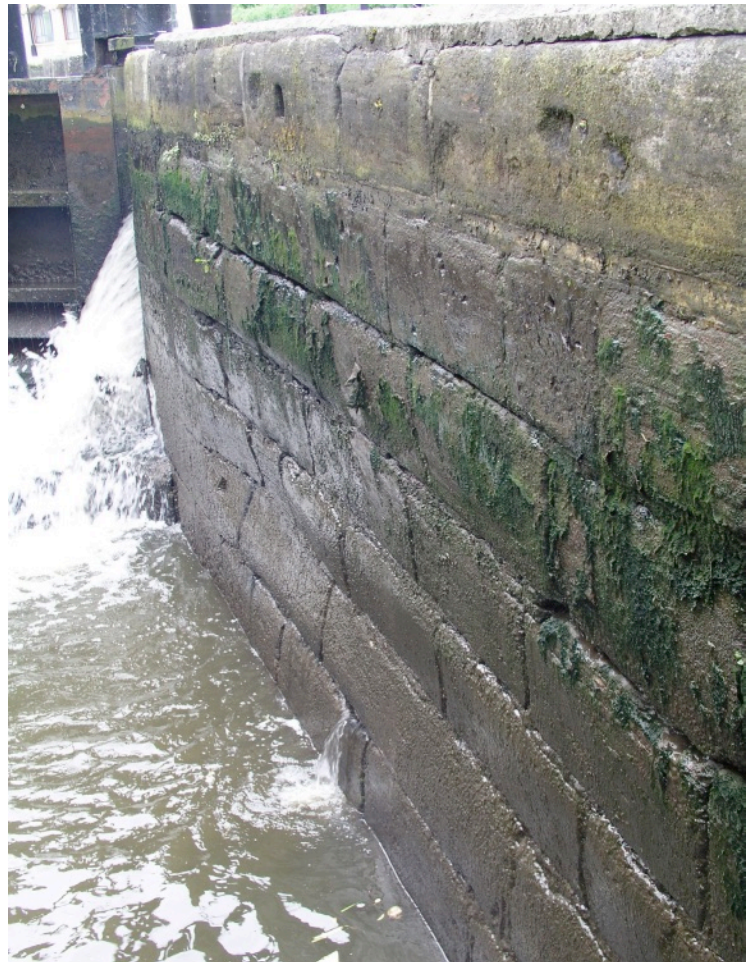
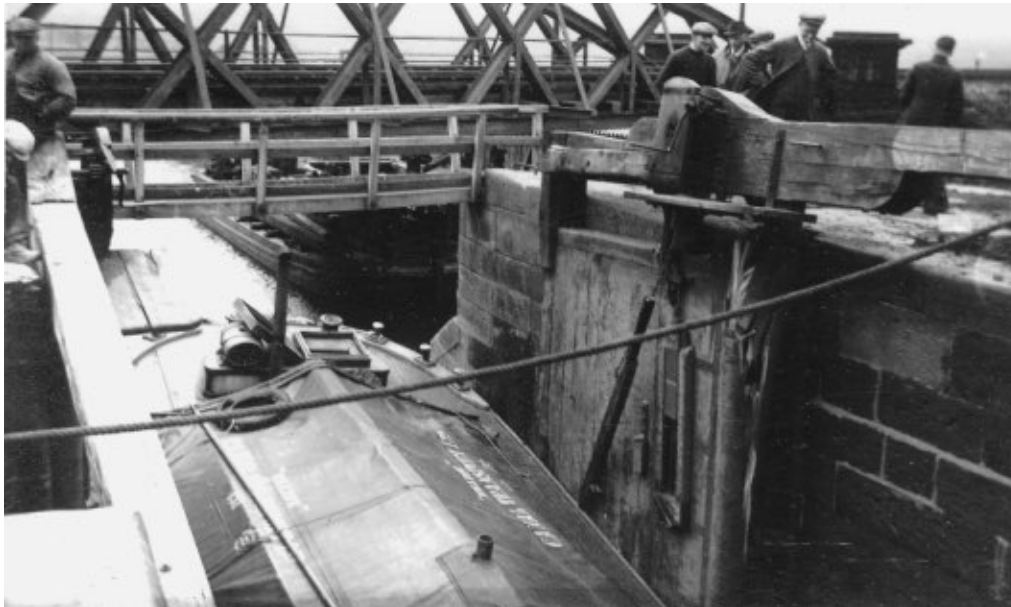
Motor boats were also strapped into locks, as this was faster than using the reversing gear. Here, on Wigan Locks, the boat *Wharfe* has broken through the gates after the strapping rope broke. The gates have been pushed backwards in the wrong direction, and the boat is stuck as the gates have no recess when folded back this way. Mining subsidence causing the

chamber to distort could have made this more likely to happen, but it was no a common occurrence. Note the paddle gear on the gate, which has the counterbalance fitted when the paddles were enlarged to speed up traffic when railway competition began in the 1840s.

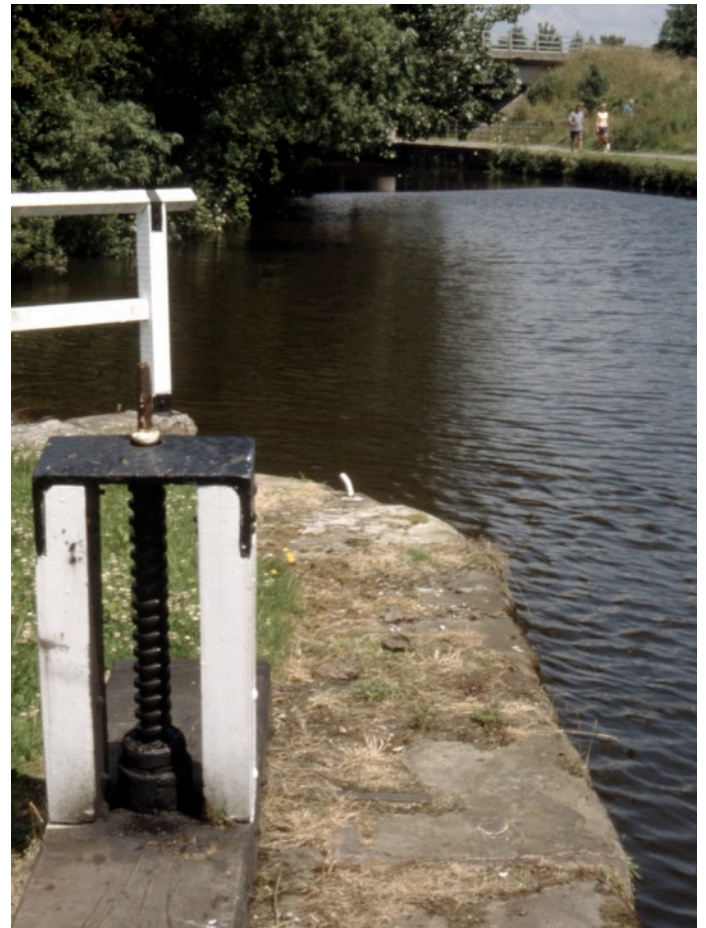
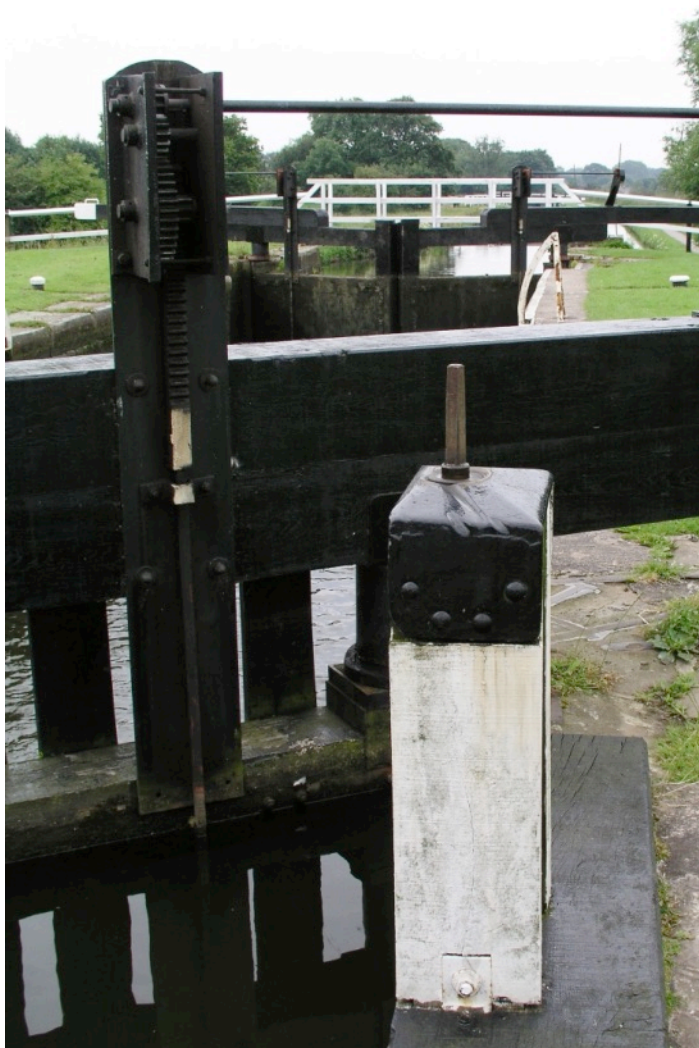
Very few of the 'starting pins' used to make it easier for horses to pull boats out of locks now survive, and the example on the right, at Barrowford, has now disappeared. They were always on the off side of the lock, and it is still possible to find where they have been cut off. The drawing below shows how they were used to create a 'double purchase' effect which halved the effort needed by a horse to start the boat out of a lock.

It is still possible to find rope marks from the days of horse boats, such as the groove on the cast iron ground paddle top here at Johnsons Hillock. When starting the boat out of the lock, the tow line was passed over the ground paddle and around the spindle such that it did not catch on anything. Few marks such as this remain, but there are still many to be found on stonework around locks and bridges.
