LOCKS

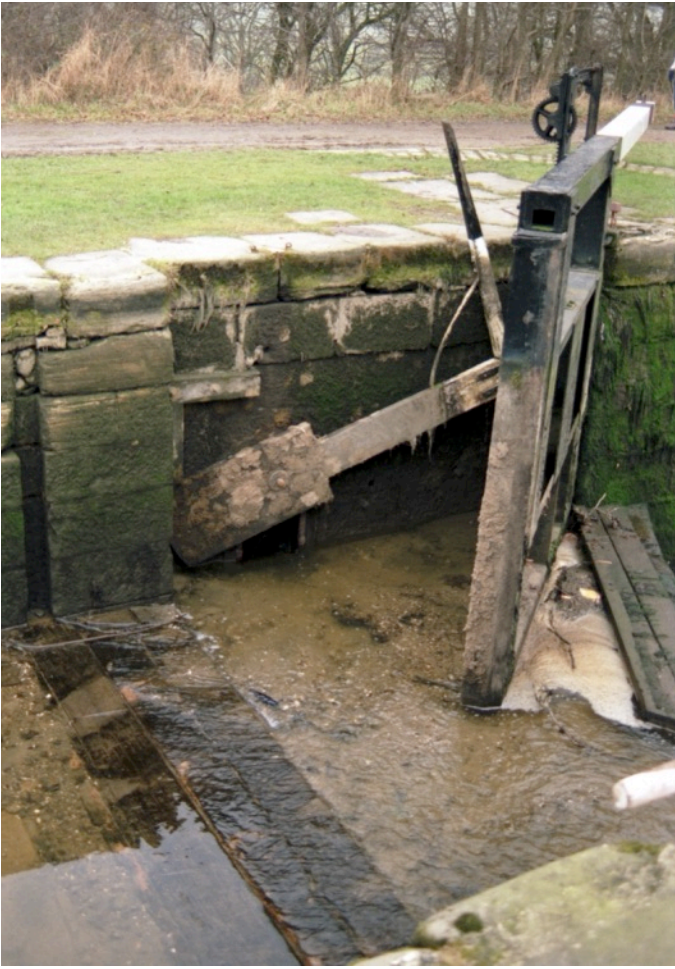
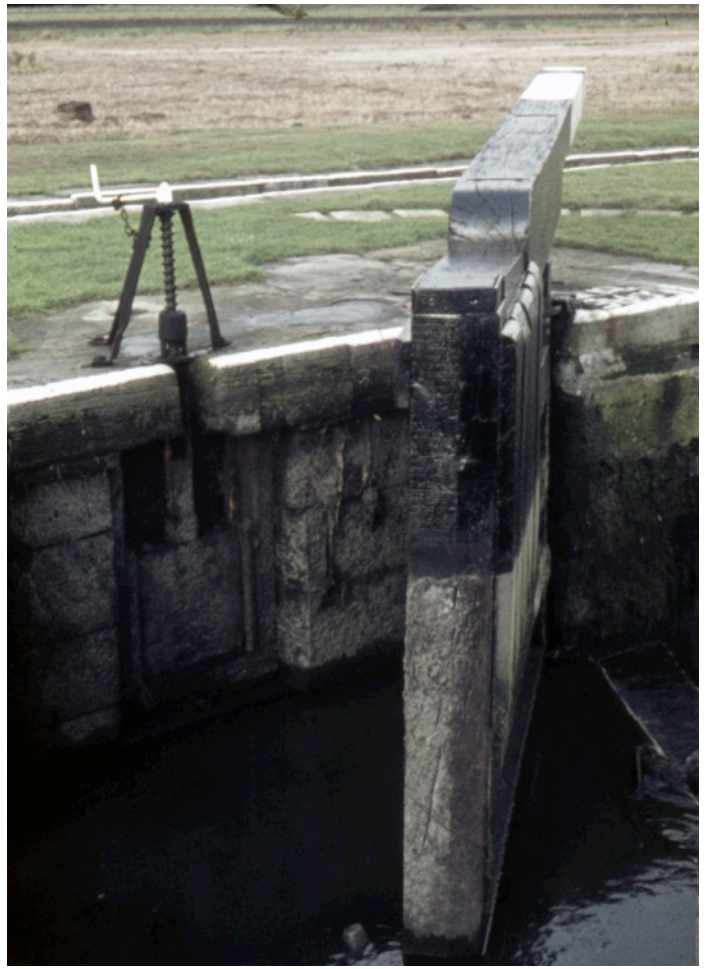
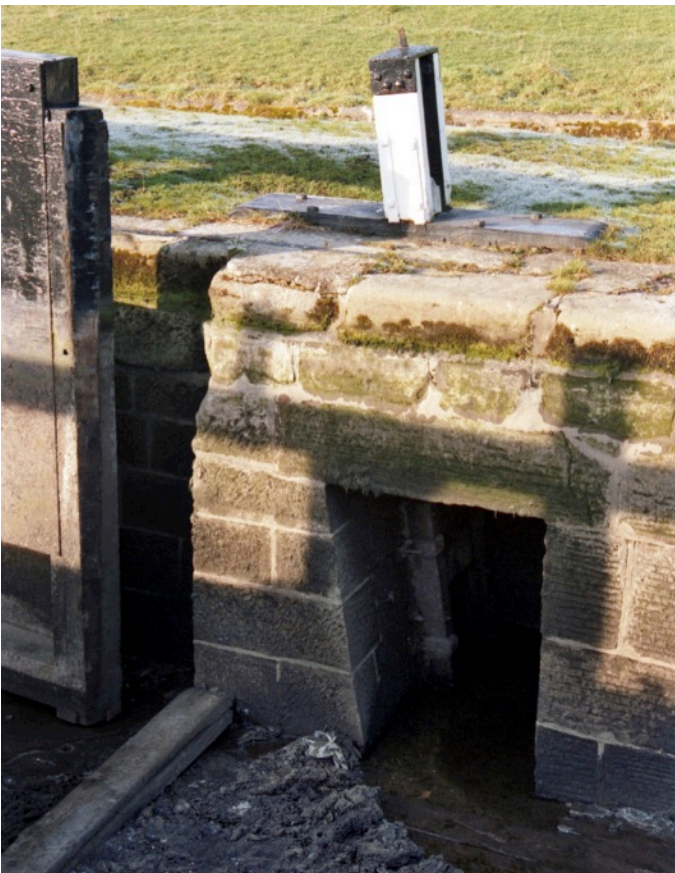
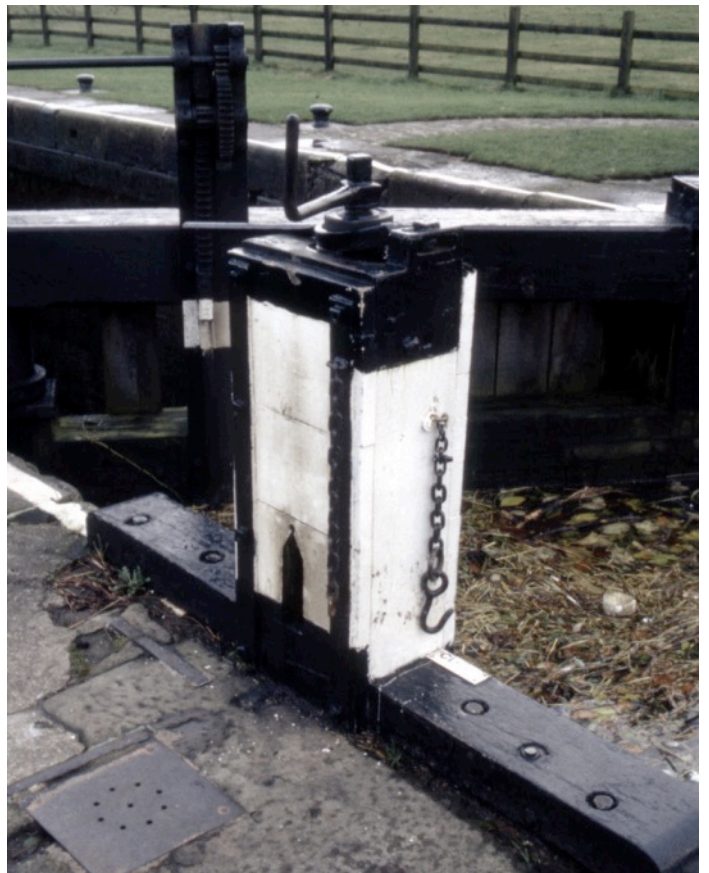
Four types of ground paddle used on the canal. Top left is an up-and-over type, here on the Bank Newton locks. Top right is an open frame box paddle found on the Rufford branch. Bottom left is a sloping box paddle as found at Barrowford and Gargrave, with bottom right a vertical box paddle with brake lever used at Greenberfield.

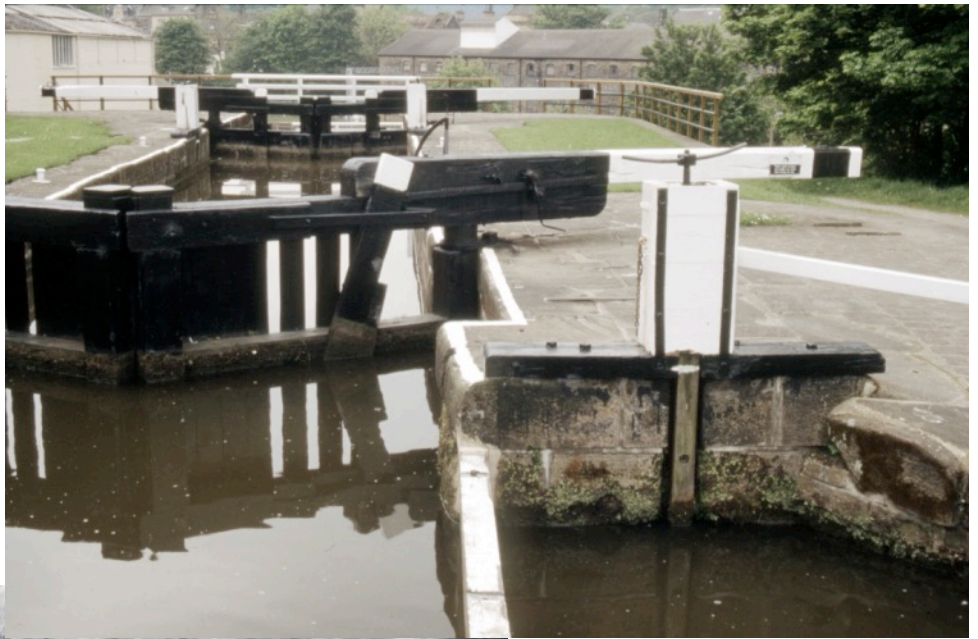
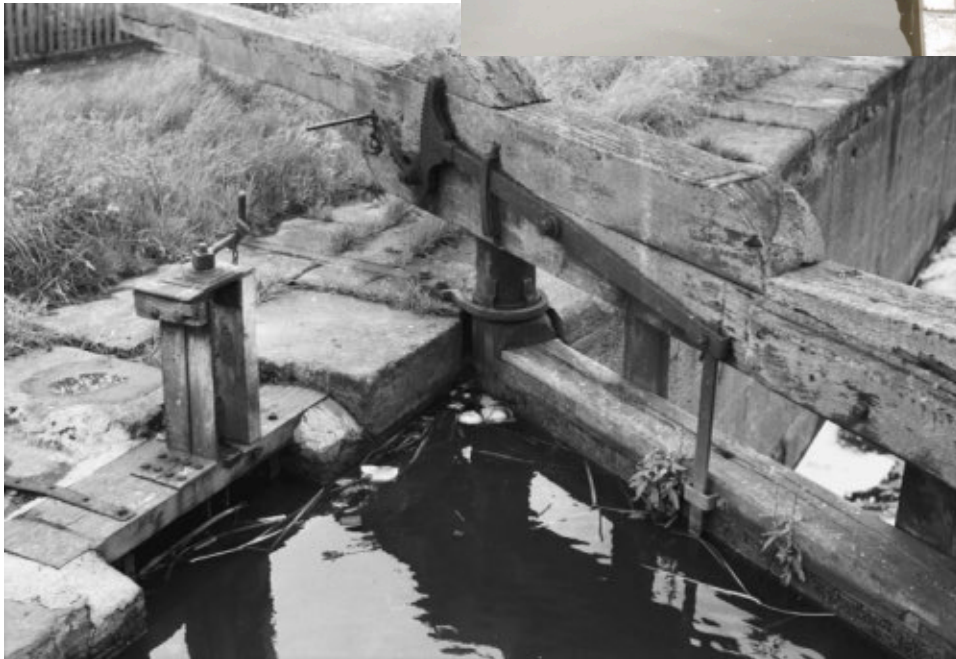
Bingley 3-rise is one of the earliest locks, and they had box ground paddles set at right angles to the chamber. Wooden guide rails were fitted later to stop boats hitting the sharp corner at the lock entrance. Later locks had curved walls to guide boats into the chamber. The gate paddles are the old scissor pattern, operated by a rack and gear.

The ground paddle here, on the Rufford branch, has had a temporary repair after one of the wooden uprights had failed. The gate paddle is of the quadrant design using a gear operated pivotted lever to raise the paddle.

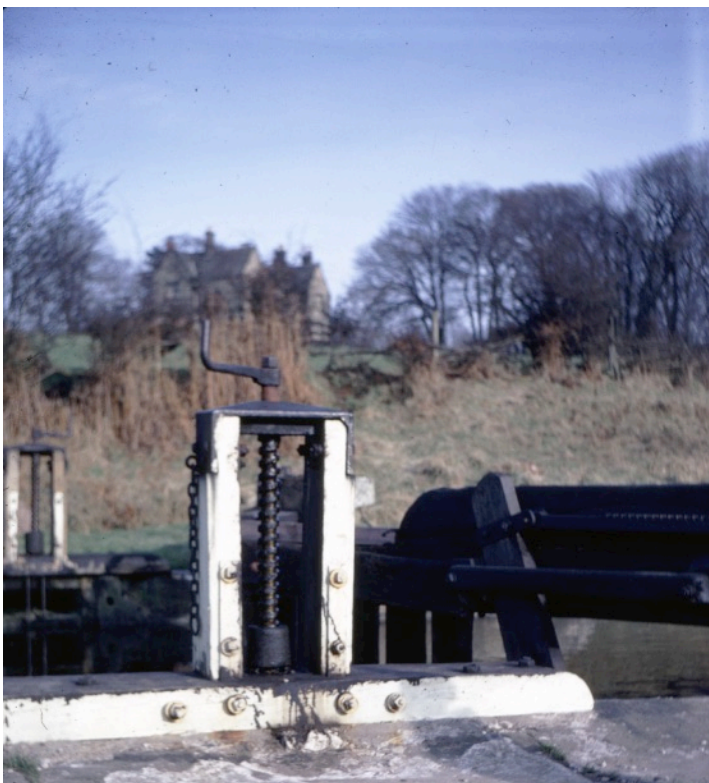
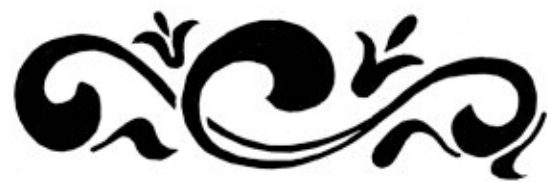
Box cloughs, as paddles were called on many northern waterways, had many different designs. In Yorkshire, as in the top photo, they were completely enclosed, while those in Lancashire often had open sides, as on the left at Johnsons Hillock Locks. The rack operated gate paddles were found everywhere on the canal.

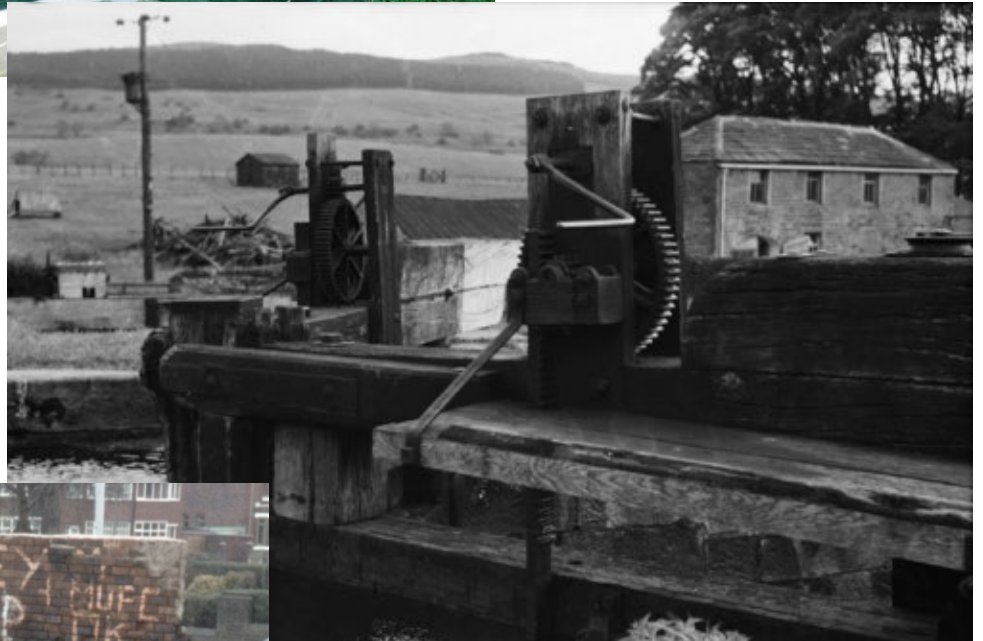
Lancashire jack cloughs, such as here at Poolstock, were slightly different, although both had to be worked from a platform fitted to the side of the gate. These are now considered dangerous, and none survive. The paddle opening size was increased in the 1850s to speed passage through the locks, and counter balances were provided to make them easier to operate.

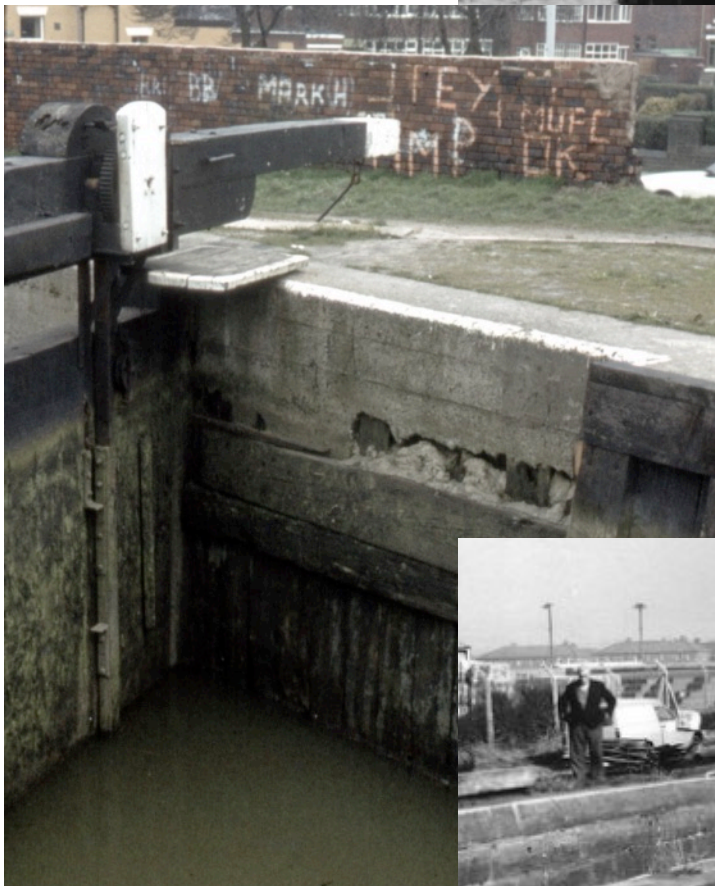
For a short period around 1970 hydraulically operated gate paddles were fitted, but they were not very successful.

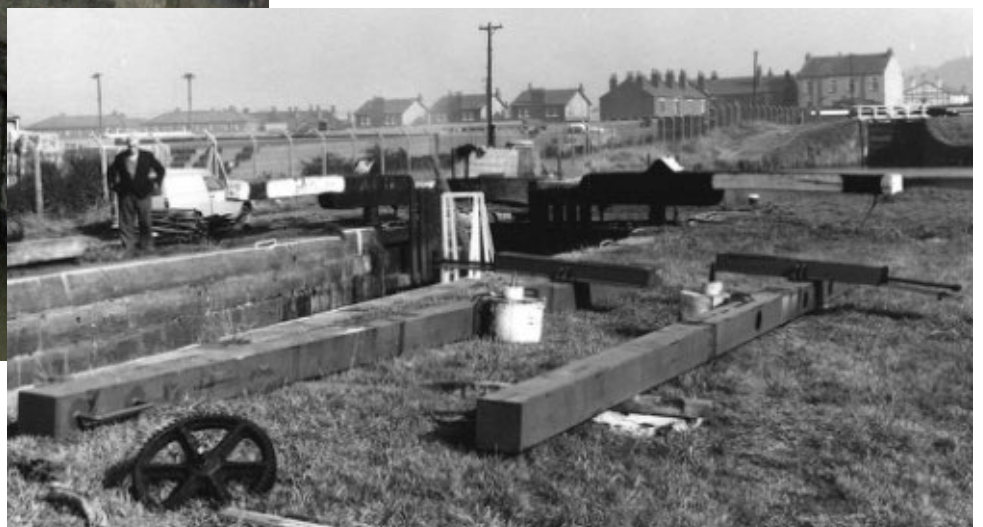
For maintaining the canal, workshops were provided at various points. The original workshop in Lancashire was at Briers Mill, near Burscough, seen on the right. The engineer for the western end of the canal was based here for many years, and there were carpenters and blacksmiths shops on the right of the photo.

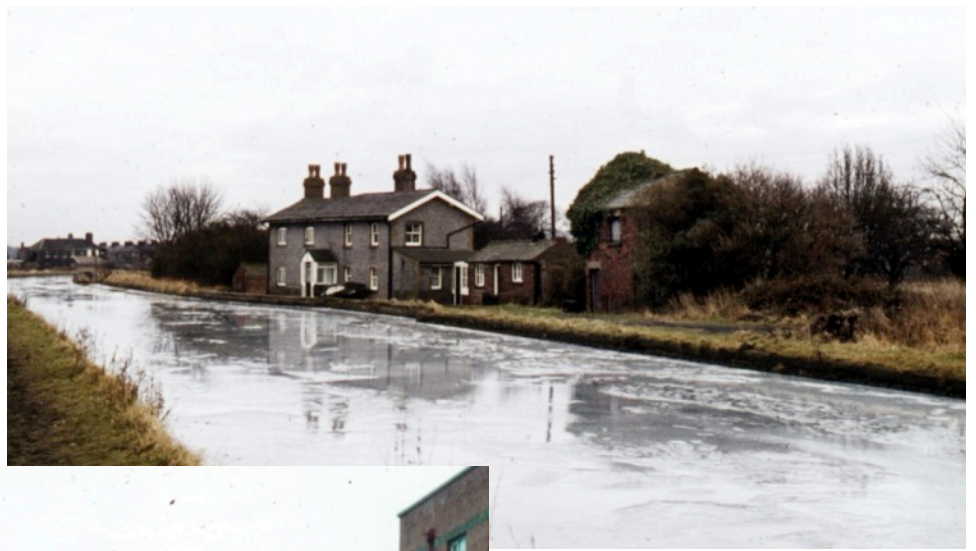
After the canal opened throughout in 1816, Wigan became an important centre, with workshops for maintaining the locks. The old carpenters shop, seen on the left, was once two storeys high, but the upper storey burnt down.

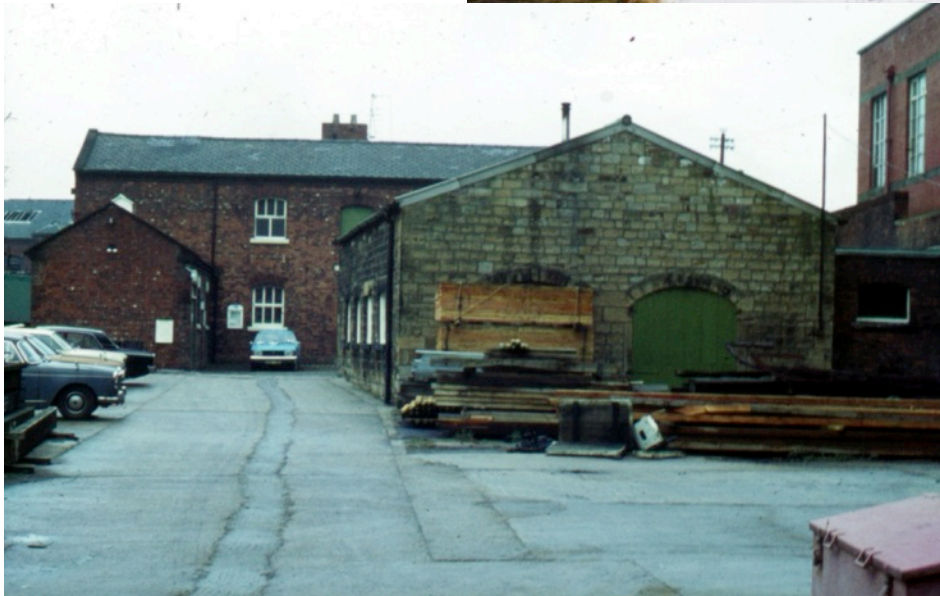
In East Lancashire, the main workshops were at Finsley Gate, Burnley, as seen on the right in 1972. As with other yards, there was a large sawmill for preparing timber.

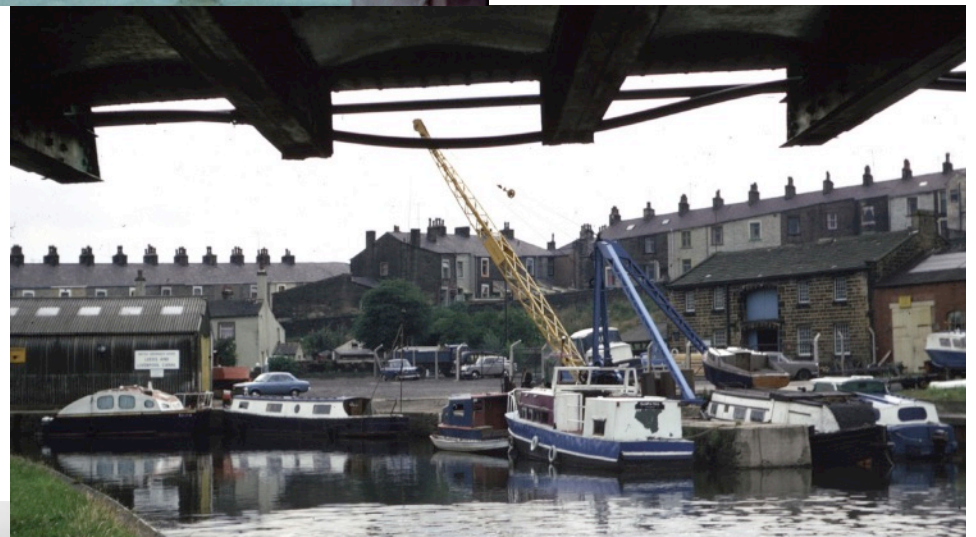
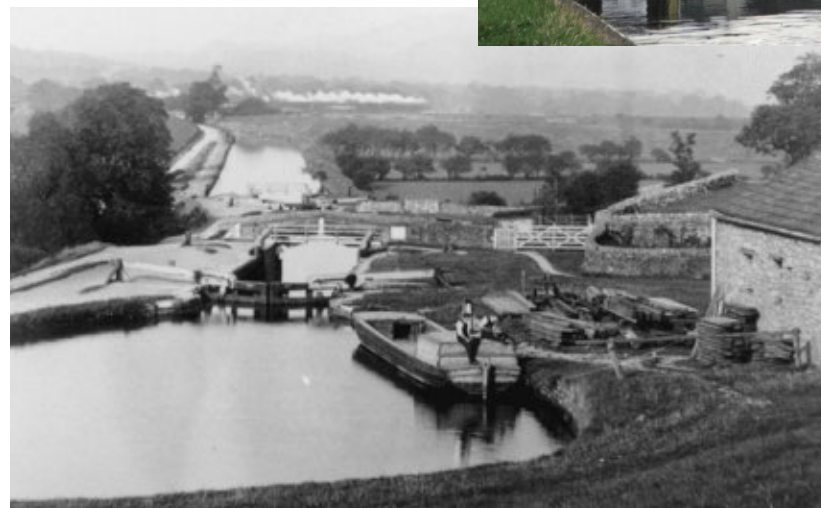
Bank Newton and Gargrave locks were maintained by the workshop at Bank Newton, which also looked after Greenberfield locks and the canal as far as Skipton.

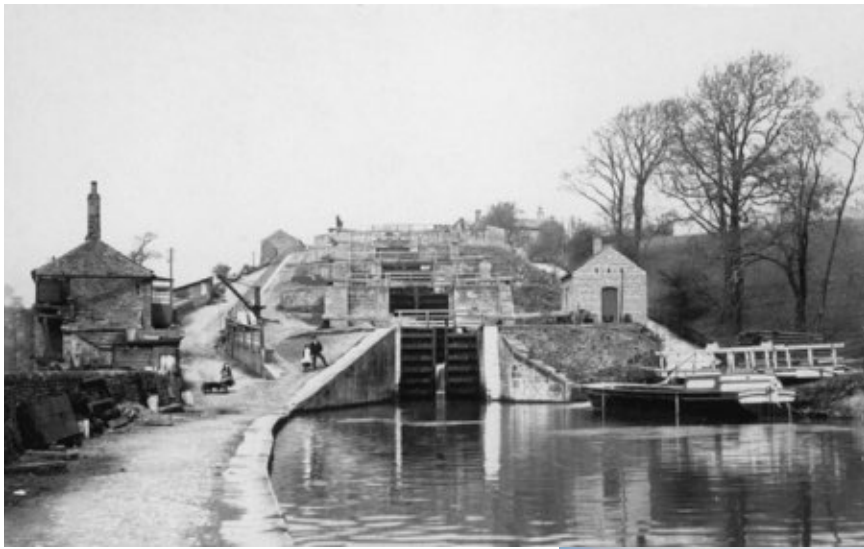
There was a carpenters shop at Bingley for maintaining the locks there, as well as the numerous swing bridges on the Skipton Pool. There was a crane at the bottom of the locks to serve the workshop, with swing bridges built on land opposite at the bottom of the locks. They were carried by boat to site for installation.

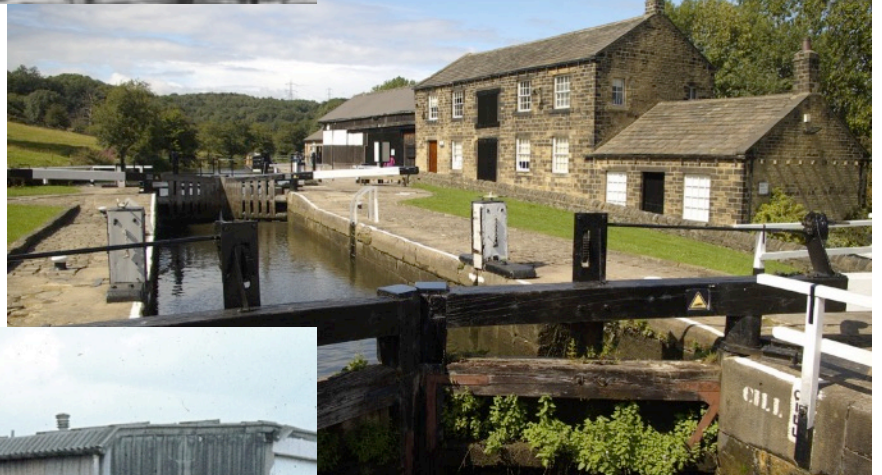
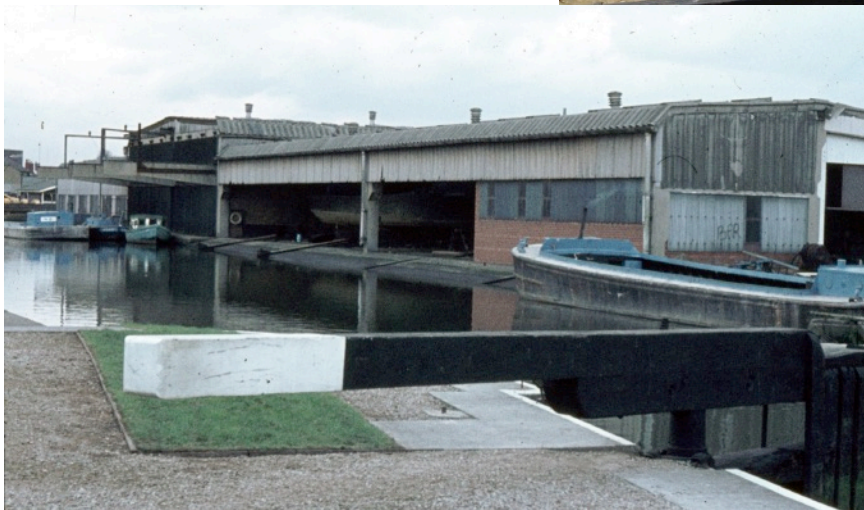
In the 1950s, new workshops were built at Wigan, where lock gates for all of the canals in the north west were made. There were also new slipways for maintaining the work boats.
